LICHFIELD DISTRICT  
GRADE II  
HERITAGE AT RISK  
2013

## **2.0 Grade II Heritage at Risk Survey of Lichfield District**

**Grade II Heritage at Risk.**  
(Grade I and II\* form part of a report by English Heritage)

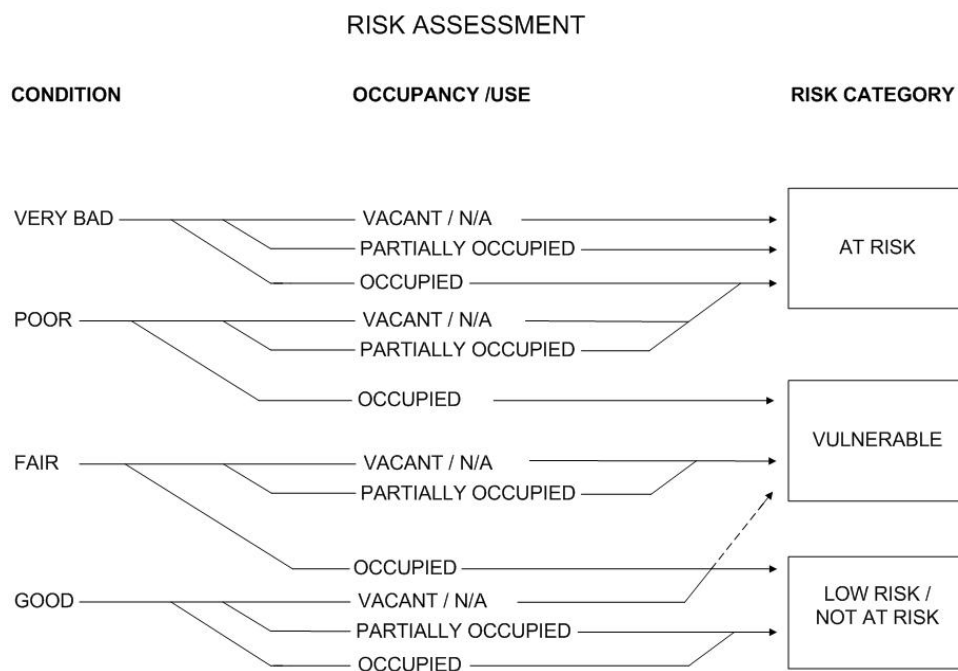
The overall risk assessment is calculated by a combination of condition and occupancy, using the table below. Structures which cannot be occupied are assessed on condition alone.

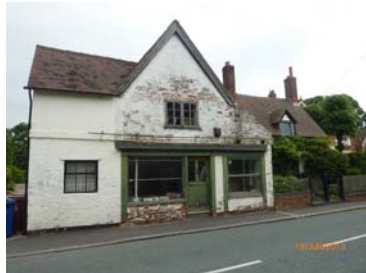
<b>HAR Ref:</b>	1295195	<p><b>Description:</b> C17, remodelled in the early C18. Timber framed core with the outer walls rebuilt in brick and painted. No.115 to the rear is occupied however this ex shop is vacant.</p>

<b>Address:</b>	113 and 115 Main Street, Alrewas		
<b>Conservation Area:</b>	Y		
<b>Condition:</b>	Poor		
<b>Occupancy:</b>	Part occupied		
<b>Priority Category:</b>	C		
<b>Year of survey:</b>	2013

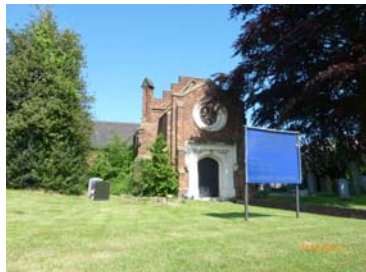
<b>HAR Ref:</b>	1382060	<p><b>Description:</b> An 1820 Congregational chapel by Thomas Birch. The building is in a slow state of decay, with substantial vegetation growth around the building.</p>

<b>Address:</b>	Armitage United Reform Church, Rugeley Road, Armitage		
<b>Conservation Area:</b>	N		
<b>Condition:</b>	Poor		
<b>Occupancy:</b>	Vacant		
<b>Priority Category:</b>	C		
<b>Year of survey:</b>	2013

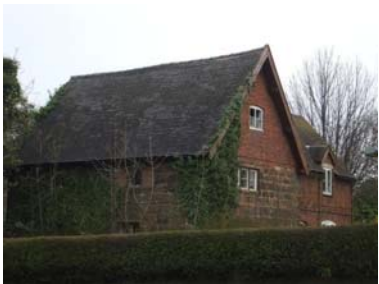
<b>HAR Ref:</b>	1038768	<b>Description:</b> Pair of houses. Late C17 with early C18 and C19 alterations.

<b>Address:</b>	Stonehouses Cottages, Rugeley Road, Armitage		
<b>Conservation Area:</b>	N		
<b>Condition:</b>	Fair		
<b>Occupancy:</b>	Vacant		
<b>Priority Category:</b>	C		
<b>Year of survey:</b>	2009

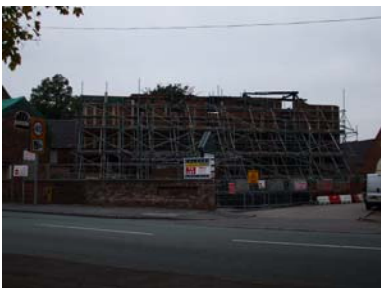
<b>HAR Ref:</b>	1038804	<b>Description:</b> Early C19 watermill. Rectangular plan with wheel to left. Brick, roughly coursed into English garden wall band with gabled Welsh slate roof. Three storeys and loft and carriage arch to right.

<b>Address:</b>	Bonehill Mill, Lichfield Street, Fazeley		
<b>Conservation Area:</b>	Y		
<b>Condition:</b>	Very Bad		
<b>Occupancy:</b>	Vacant		
<b>Priority Category:</b>	A		
<b>Year of survey:</b>	2011

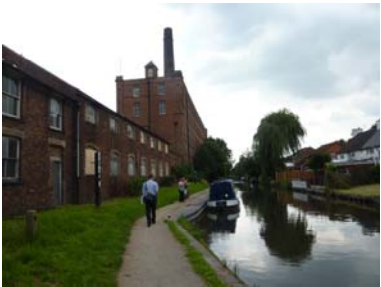
<b>HAR Ref:</b>	1245134	<b>Description:</b> 1886 textile factory built for William Tolson Ltd, by Messrs Wattons of Lichfield. 5-storey weaving block of 29 bays aligned north-south parallel to the Birmingham and Fazeley canal to the west.

<b>Address:</b>	Fazeley Mill, Lichfield Street, Fazeley		
<b>Conservation Area:</b>	Y		
<b>Condition:</b>	Fair		
<b>Occupancy:</b>	Part occupied		
<b>Priority Category:</b>	D		
<b>Year of survey:</b>	2011

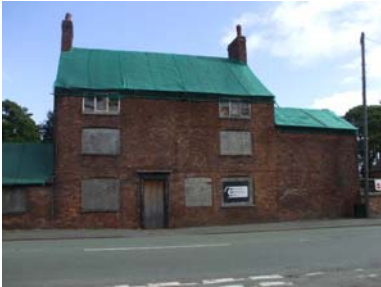
<b>HAR Ref:</b>	1374314	<b>Description:</b> Early C19 brick millhouse, now house. 3 storeys; 2-window range. Forms part of a group with Bonehill Mill and Nos 116-120 (even) Lichfield Street.

<b>Address:</b>	122 Lichfield Street, Fazeley		
<b>Conservation Area:</b>	Y		
<b>Condition:</b>	Very bad		
<b>Occupancy:</b>	Vacant		
<b>Priority Category:</b>	A		
<b>Year of survey:</b>	2011

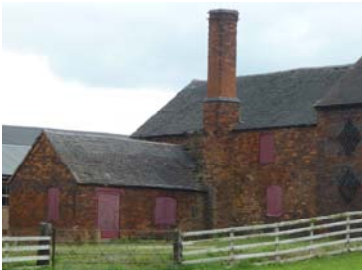
<b>HAR Ref:</b>	1263819	<b>Description:</b> Farm outbuildings comprising barns and former smithy. Mid to late C18 with C19 additions and alterations.  Affected by HS2 route.

<b>Address:</b>	L Shaped range of buildings, Bucks Head Farm, Watling Street, Hints		
<b>Conservation Area:</b>	N		
<b>Condition:</b>	Poor		
<b>Occupancy:</b>	Part in use		
<b>Priority Category:</b>	D		
<b>Year of survey:</b>	2013

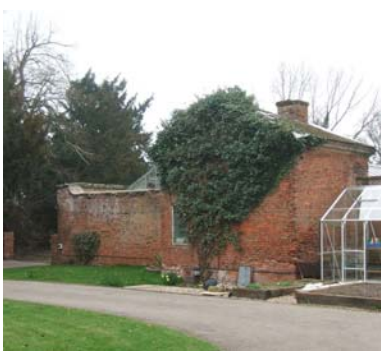
<b>HAR Ref:</b>	1248775	<b>Description:</b> C18 walls and pavilions within the former grounds of the now demolished King's Bromley Manor.

<b>Address:</b>	Garden walls and pavilions at Manor Park, Kings Bromley		
<b>Conservation Area:</b>	Y		
<b>Condition:</b>	Poor		
<b>Occupancy:</b>	Not applicable		
<b>Priority Category:</b>	C		
<b>Year of survey:</b>	2013

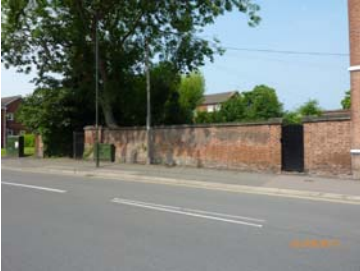
<b>HAR Ref:</b>	1292295	<b>Description:</b> Wall and gates. Mid C19. Brick with moulded ashlar capping. Gate to left end is carriage entrance to Lombard Gardens. Wall is leaning with missing coping stones, spalling and missing brick and mortar.

<b>Address:</b>	Wall extending 14m SW from No 35 Lombard Street, Lichfield.		
<b>Conservation Area:</b>	Y		
<b>Condition:</b>	Poor		
<b>Occupancy:</b>	Not applicable		
<b>Priority Category:</b>	C		
<b>Year of survey:</b>	2013

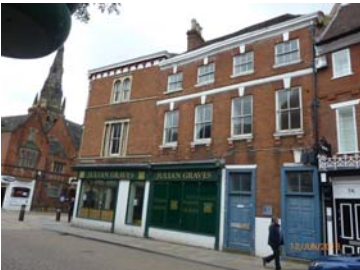
<b>HAR Ref:</b>	1218375	<b>Description:</b> c1750 and c1850. Brick with ashlar and stucco dressings. The walls and windows and doors are in poor condition, with the rainwater goods also needing some attention

<b>Address:</b>	1,3 and 5 Tamworth Street, Lichfield		
<b>Conservation Area:</b>	Y		
<b>Condition:</b>	Poor		
<b>Occupancy:</b>	Vacant		
<b>Priority Category:</b>	C		
<b>Year of survey:</b>	2013

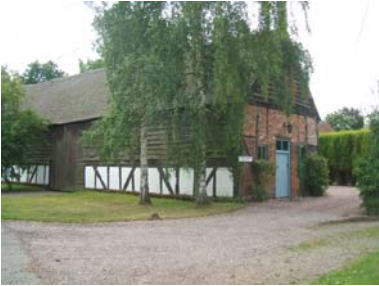
<b>HAR Ref:</b>	1248907	<b>Description:</b> Late C17 barn and stables. One storey, weather-boarded timber framing with some brick infill; plain tile roof.

<b>Address:</b>	The Tithe Barn, Church Lane, Mavesyn Ridware		
<b>Conservation Area:</b>	Y		
<b>Condition:</b>	Poor		
<b>Occupancy:</b>	Part occupied		
<b>Priority Category:</b>	C		
<b>Year of survey:</b>	2013

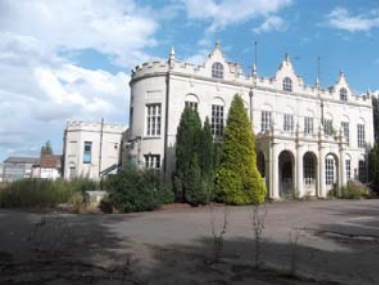
<b>HAR Ref:</b>	1038837	<b>Description:</b> Country house, now offices. Mid C18, reputedly by Benjamin Wyatt; rendered in the C19 with other alterations.

<b>Address:</b>	Packington Hall, Tamworth Road, Packington		
<b>Conservation Area:</b>	N		
<b>Condition:</b>	Very bad		
<b>Occupancy:</b>	Vacant		
<b>Priority Category:</b>	A		
<b>Year of survey:</b>	2012

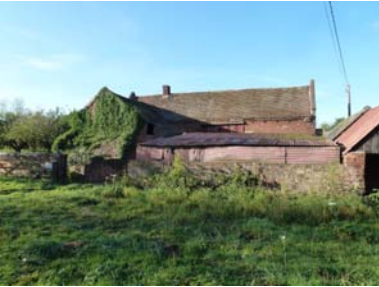
<b>HAR Ref:</b>	1038867	<b>Description:</b> C18 red brick barn and granary. 4-bay range aligned north-west/south-east.

<b>Address:</b>	Barn & Granary, 5m NE of Blue Gates Farm		
<b>Conservation Area:</b>	N		
<b>Condition:</b>	Fair		
<b>Occupancy:</b>	Vacant		
<b>Priority Category:</b>	F		
<b>Year of survey:</b>	2013

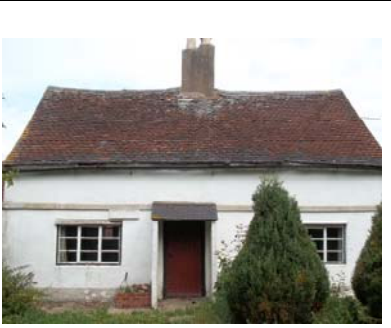
<b>HAR Ref:</b>	1038908	<b>Description:</b> Farmhouse circa 1700 with later alterations. Brick, plastered and lined as ashlar. 2-cell baffle-entry main range facing south-west.

<b>Address:</b>	Blue Gates Farmhouse		
<b>Conservation Area:</b>	N		
<b>Condition:</b>	Fair		
<b>Occupancy:</b>	Vacant		
<b>Priority Category:</b>	F		
<b>Year of survey:</b>	2013

- 2 Coleshill Street Fazeley
- 59 Coleshill Street Fazeley
- Blue Gates Farmhouse and Barn.
