River Mease SSSI/SAC Restoration Plan

Client: Natural England
 Project: River Mease SSSI/SAC Restoration Job No: B1753400
 Document Title: River Mease SSSI/SAC Restoration Plan

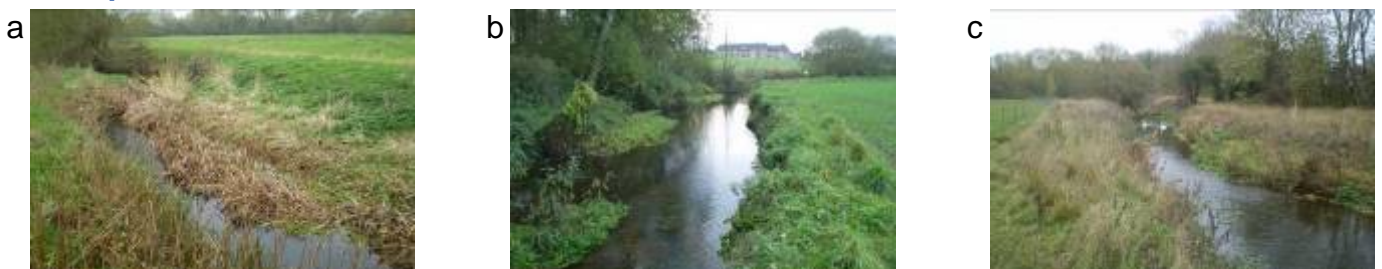
Figure 1: Adjustment by (a) natural narrowing, (b) deposition on the bed and (c) riffle development

This adjustment towards a channel morphology typical of this river type (see Figure 1 for examples) is significant and demonstrates that the river is capable of recovering without intervention in some places, and secondly it provides an indication as to the type of restoration actions which are likely be successful.

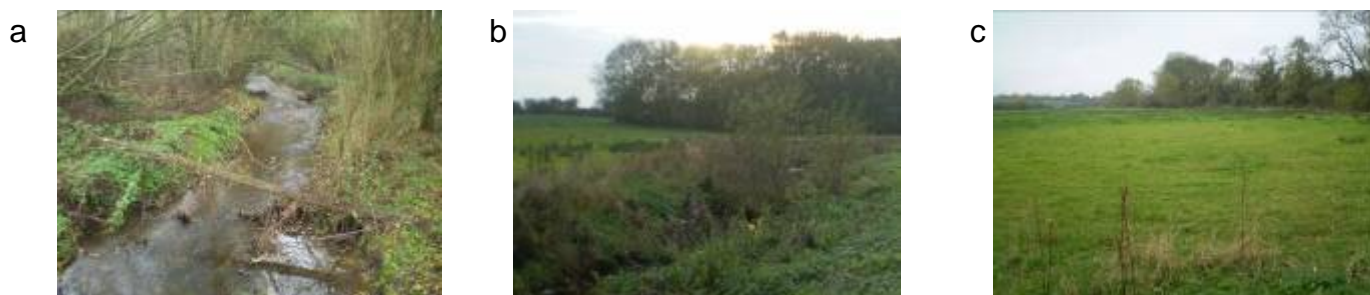
Figure 2: Examples of optimal floodplain habitats (a) wet woodland along Gilwiskaw Brook (GIL005), (b) wet grassland with open channel margin (MEA011) and (c) wet grassland with tree lined channel (MEA014).

In order to deliver **optimal** river channel processes and form, it would be necessary to both improve the morphology of the river channel and also address the impact of land use pressures on the floodplain. Ideally this would involve ending the drainage of the floodplain on the outer boundary and establishing a mosaic of wet grassland and wet woodland habitats on the entire floodplain. This would not preclude the use of the floodplain for agriculture, as grazing of this new habitat would be desirable to help maintain different habitats, however it would be a significant shift from the current farming systems. The floodplain would still be managed, but managed in a way that would deliver optimal conditions for the SSSI/SAC. There are some locations along the SSSI/SAC which provide examples of the range of habitat we would ideally like to encourage (Figure 2).

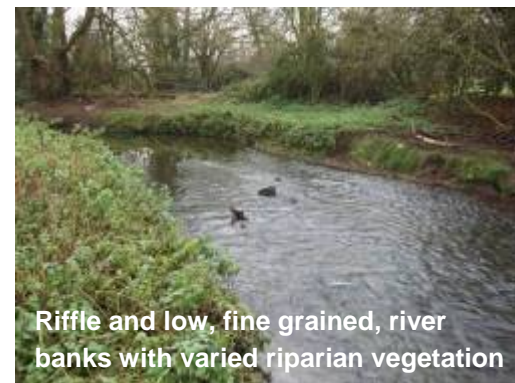
Riffle and low, fine grained, river banks with varied riparian vegetation

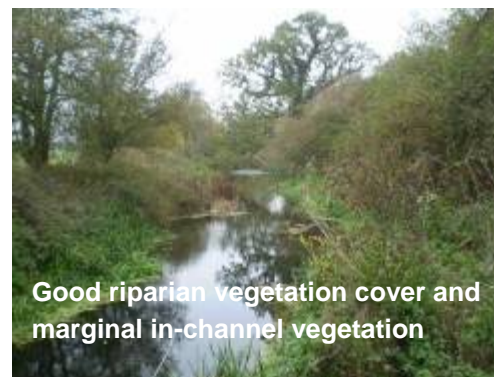
Good riparian vegetation cover and marginal in-channel vegetation

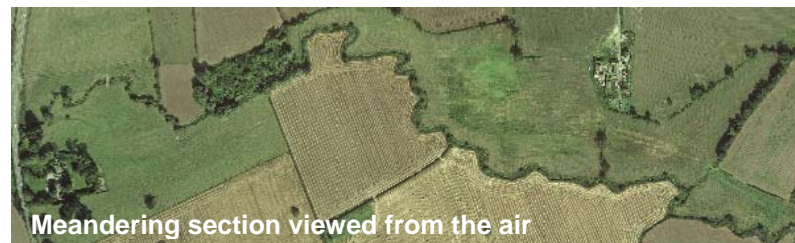
Meandering section viewed from the air

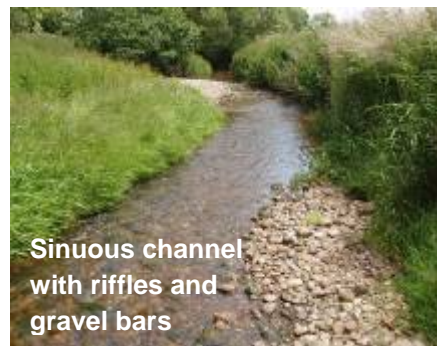
Sinuous channel with riffles and gravel bars

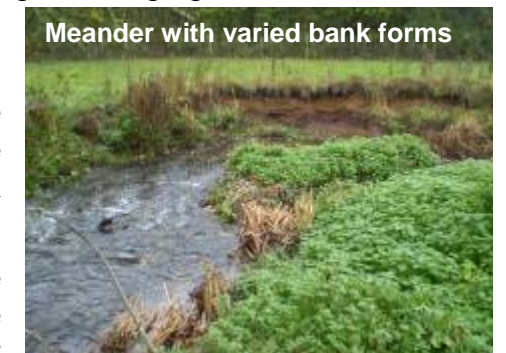
Meander with varied bank forms

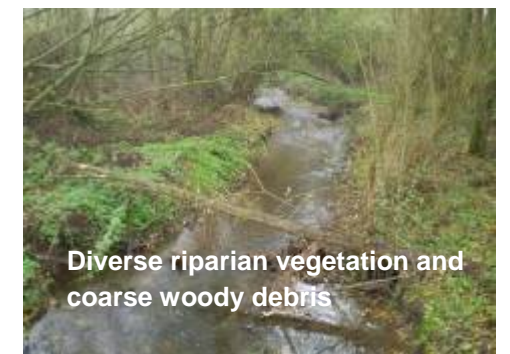
Diverse riparian vegetation and coarse woody debris

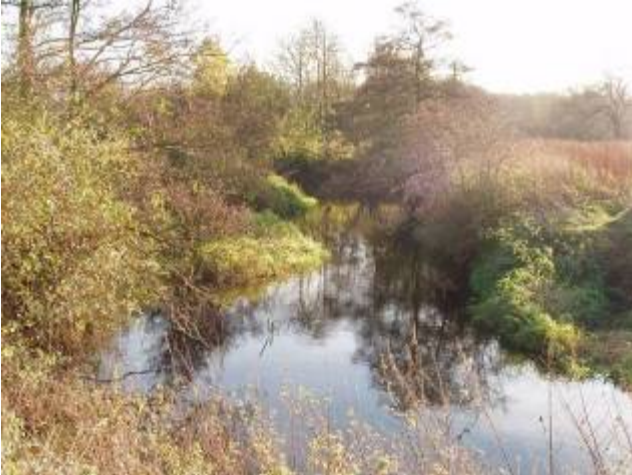
Example of a good existing riparian zone with mixed vegetation creating areas of cover and shade along the River Mease near Edingale:

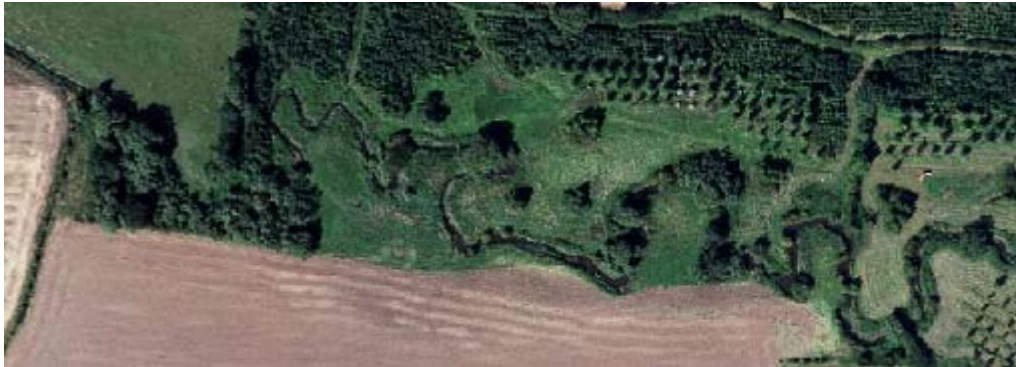
Example of a good corridor of riparian vegetation (viewed from the air) upstream from Netherseal. Note that the corridor contains a range of different vegetation types and densities and also varies in width.

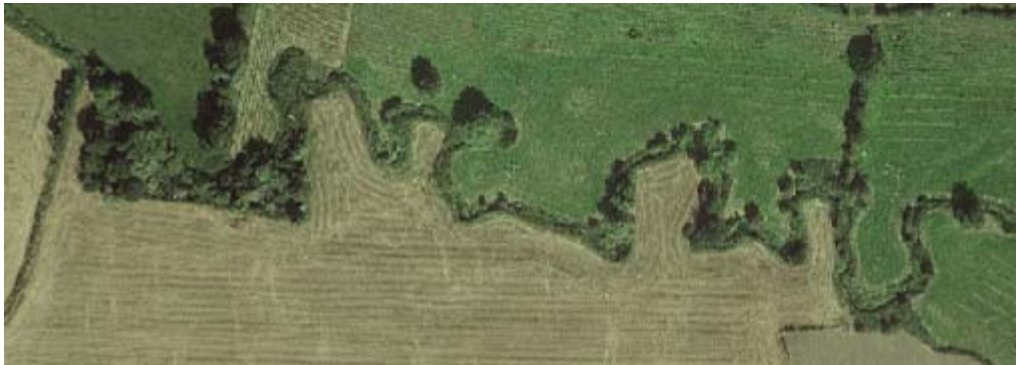
Note how this contrasts with an area of more intensive land use right up to the river bank:

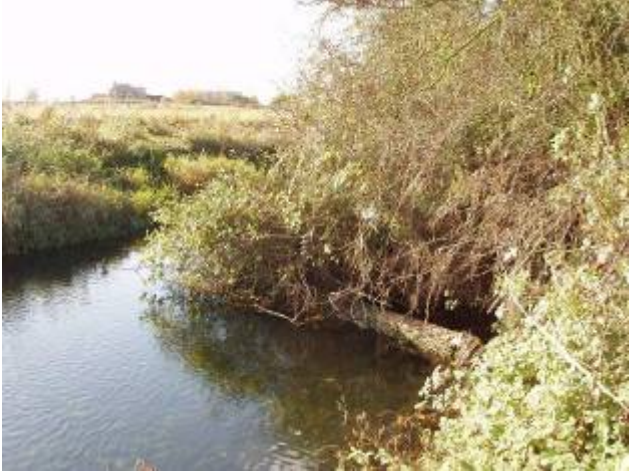
<p>Example of fallen tree creating some variation and habitat cover in an over-wide/over-deep section of the River Mease</p>

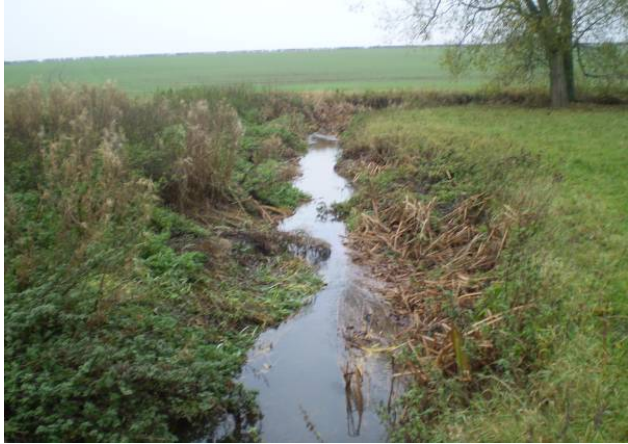
<p>Example of natural channel narrowing on the River Mease in the foreground. The bank profile is less steep and vegetation encroaches into channel. This contrasts with the bend in the distance where the bank remains high and could be improved by re-profiling.</p>

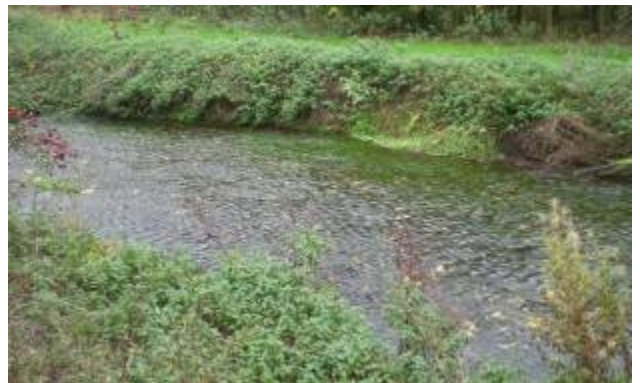
Long-section (creating areas of shallower flow across riffle and deeper flow up and downstream):

Example riffle on River Mease with shallow flow creating disturbance to water surface and some *ranunculus* beds present

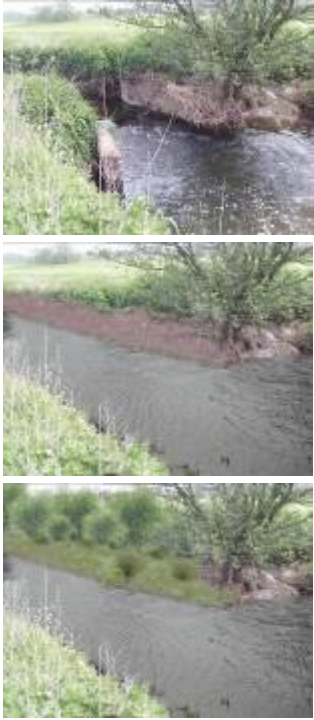
Remove Weir	Category: Restore
	Sub-options: R6 – Remove weir
<p>Description:</p> <ul style="list-style-type: none"> • Weirs create barriers to downstream passage of flow and sediments and to free-migration of fish and other fauna up and down the river channel; • Removal of weirs may involve removing the structure (wing-walls and bed stones) and bank lowering or widening (re-profiling) to help the channel re-establish a more natural form; • Existing scour pools located below a removed weir may silt up from the margins over time, this may become colonised with vegetation creating additional variation in habitat. 	<p>Illustration:</p> <p>Present</p>

<p>Present</p> <p>Remove wing walls and weir and reprofiled banks</p> <p>Following recovery (10 years)</p>
<p>Potential benefits:</p> <ul style="list-style-type: none"> • Allows more natural water level variations upstream (reduces deep water from impoundment); • Enables natural downstream sediment transport and reduces upstream silt smothering of river bed caused by impoundment; • Allows the development of more varied flow types upstream of the former structure, increasing habitat variety including potential areas suitable for <i>ranunculus</i> and other macrophytes; • Allows the river channel morphology to respond and adjust to changes in flow and sediment supply, creating diverse channel morphology; • Removes barriers or obstacles to bullhead, spined loach and other fish movement through the river system between suitable local habitats.

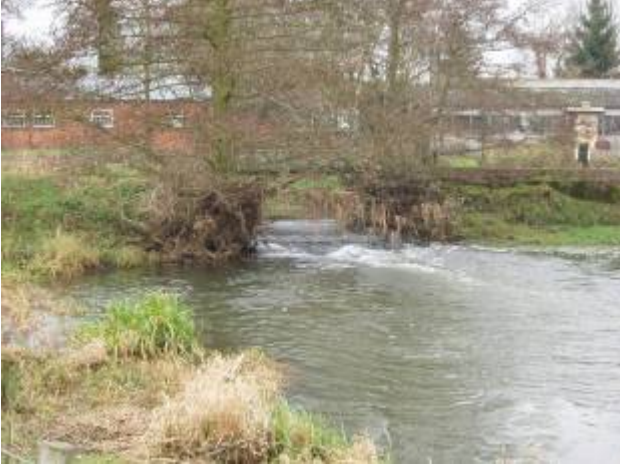
<p>Weir on the River Mease at Clifton Campville, impounding flow upstream and significant scour pool downstream</p>

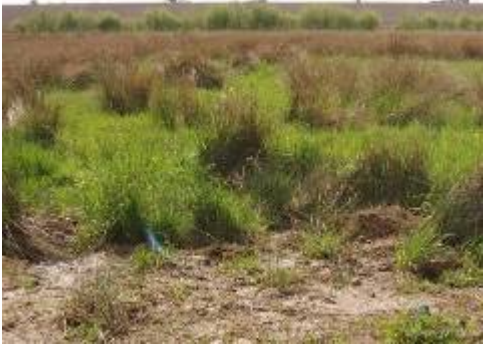
<p>Area of poorly draining rush pasture, which could be enhanced in areas close to the channel to create a more varied and functional wetland</p>

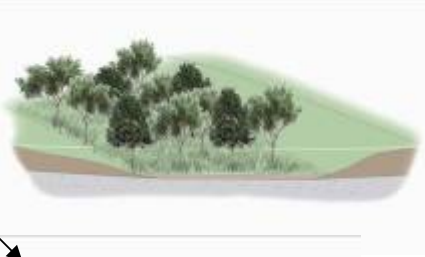
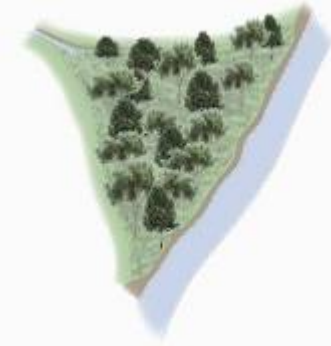
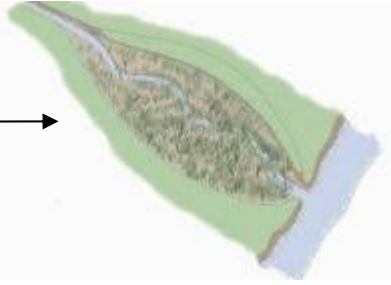
</p> <p>Widen and slightly deepen channel and create low lying area of wetland and wet woodland.</p> <p><u>Marginal reed beds</u> Widen and slightly deepen channel and create low, waterlogged ledges along the margins of a narrow low flow channel</p>

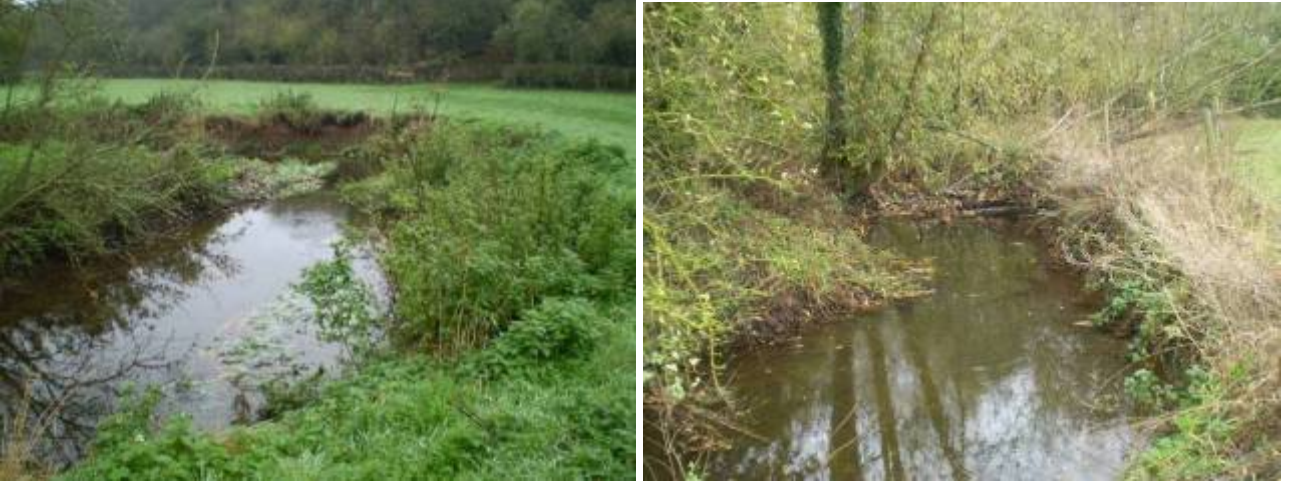
Description	Photographs
<p>Reach GIL007 Start NGR 434047 310411 End NGR 433656 310072</p> <p>Key features:</p> <ul style="list-style-type: none"> • Meandering section showing evidence of adjustment and recovery towards a more typical morphology, through localised bank erosion and deposition (gravel point bars), which is leading to the development of a highly varied channel morphology (pools and riffles). • Supply of coarse woody debris, which when located in the channel adds to flow diversity and the creation of microhabitat patches. <p>Conservation actions:</p> <ul style="list-style-type: none"> • Improve the riparian zone, particularly along the right bank. This should involve creating a strip of natural riparian vegetation parallel to the bank top.

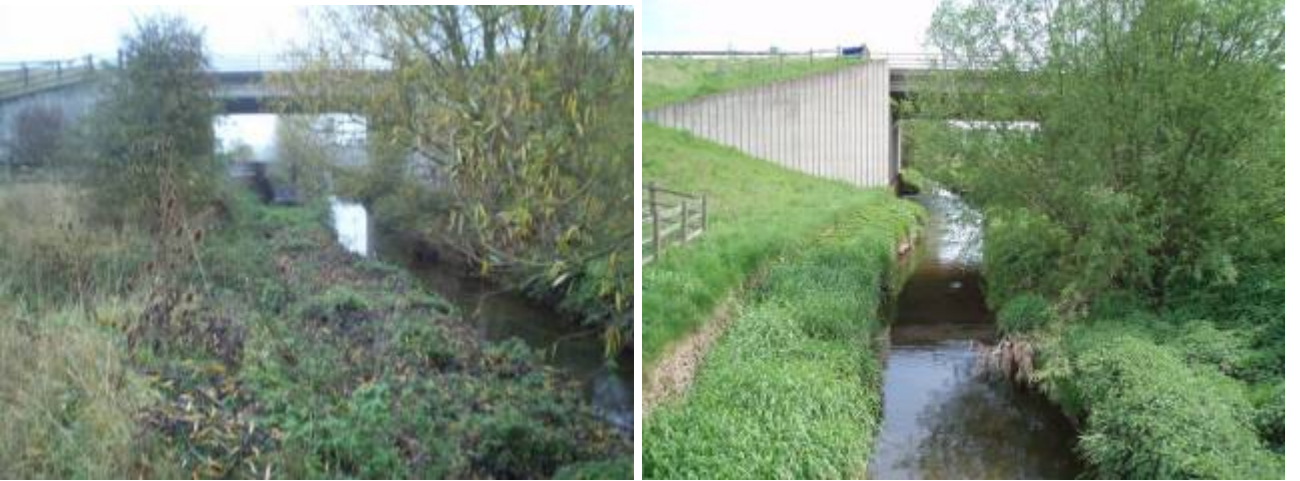
<p>Reach MEA006 Start NGR 431527 311949 End NGR 431459 312042</p> <p>Key features:</p> <ul style="list-style-type: none"> • Highly modified section of channel passing beneath the A42 trunk road. • The channel has been straightened and substantially over-widened. • However, it has now adjusted towards a more natural channel form through narrowing following the deposition of sediment along the banks and subsequent colonisation by vegetation including some trees. <p>Conservation actions:</p> <ul style="list-style-type: none"> • Due to the constraints in this location (trunk road and access routes) it is unlikely that the channel can be further improved. Attention should focus on preventing actions which may degrade the channel (e.g. vegetation clearance or dredging).

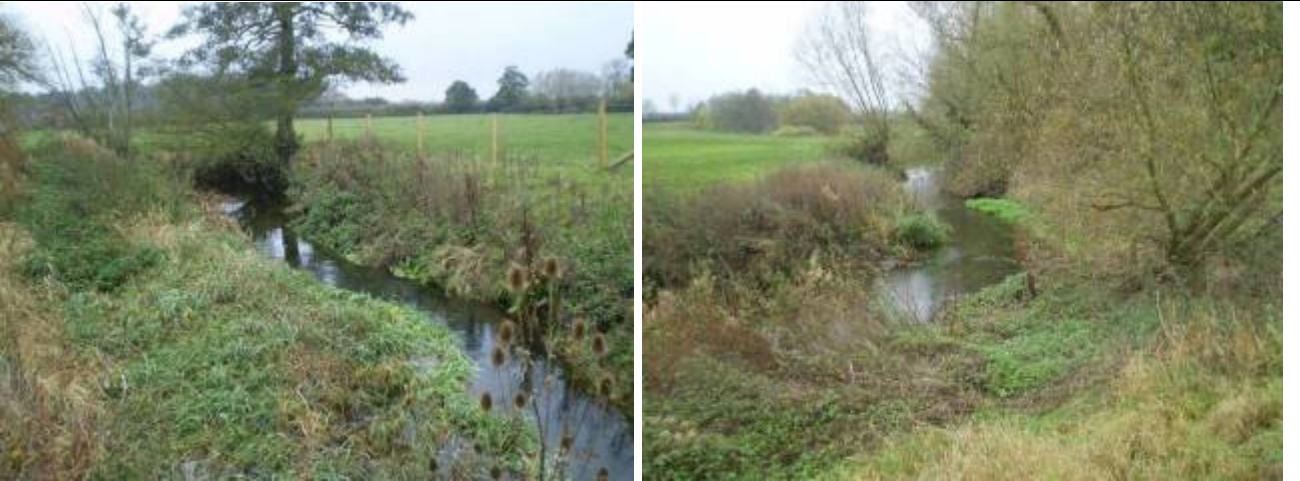
<p>Reach MEA009 Start NGR 428674 312761 End NGR 427658 311984</p> <p>Key features:</p> <ul style="list-style-type: none"> • Evidence of adjustment and recovery, through narrowing as a result of marginal sediment deposition and colonisation of deposits by vegetation, which is leading to the development of varied channel morphology (range of flow velocities). • Channel banks and margins have good vegetation cover indicating little erosion or disturbance of the banks. <p>Conservation actions:</p> <ul style="list-style-type: none"> • Increase the width of the riparian zone along both banks. This should involve creating a corridor of natural riparian vegetation. The riparian zone should encompass the floodplain on the inside of meanders.

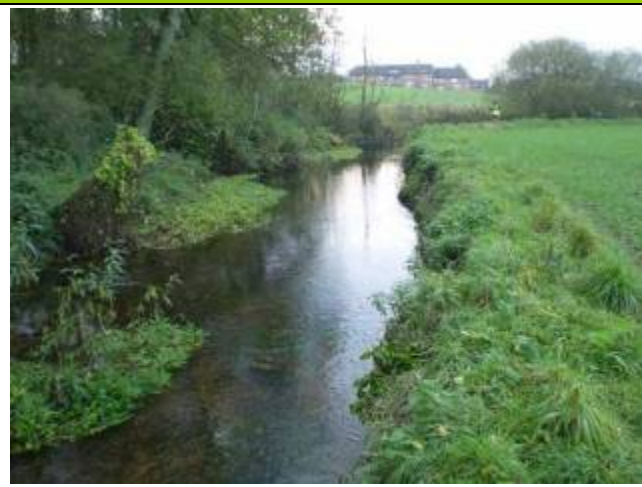
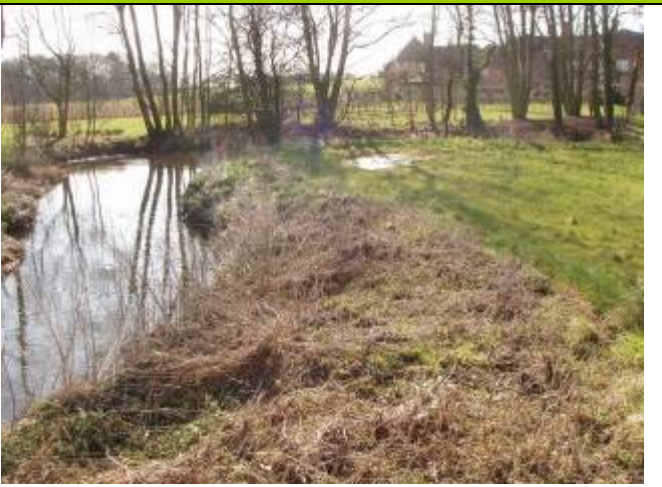
Description	Photographs	
<p>Reach MEA012 Start NGR 2426814 311073 End NGR 426197 311465</p> <p>Key features:</p> <ul style="list-style-type: none"> • Meandering section of river with a natural planform undergoing adjustment, through narrowing as a result of marginal sediment deposition and colonisation of deposits by vegetation. • Localised sediment deposition on the bed creates occasional riffles. • Channel banks and margin have good vegetation cover. <p>Conservation actions:</p> <ul style="list-style-type: none"> • Restore a corridor of natural riparian vegetation along both banks. The riparian corridor should encompass the floodplain on the inside of meanders.

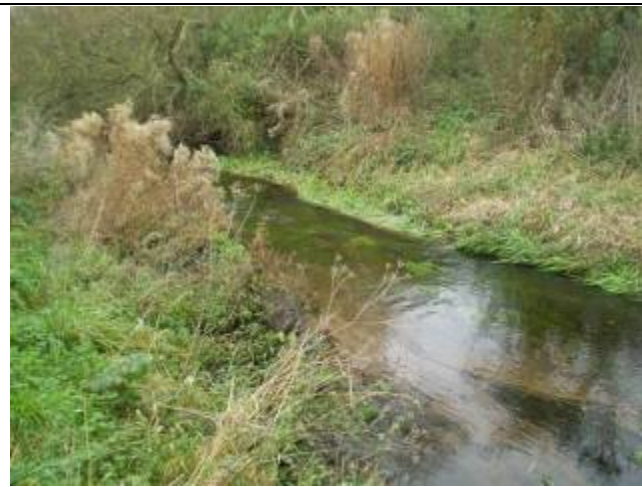
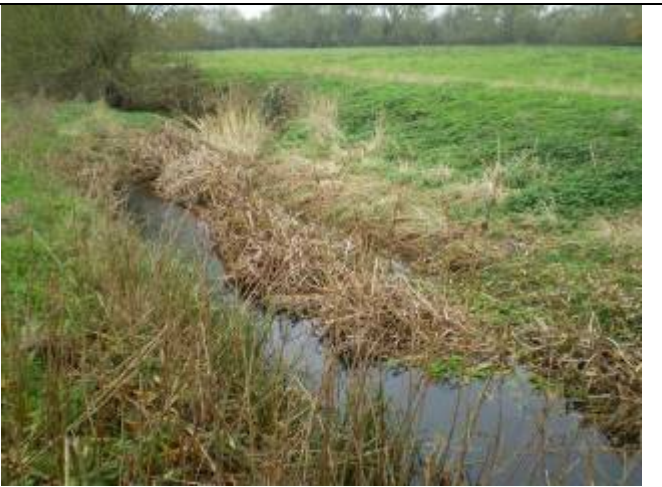
<p>Reach MEA014 Start NGR 425232 311450 End NGR 423819 311368</p> <p>Key features:</p> <ul style="list-style-type: none"> • Meandering section of channel which is located along the valley side in a number of sections. • Evidence of natural adjustment, through narrowing as a result of marginal sediment deposition and colonisation of deposits by vegetation. • Localised sediment deposition on the bed has created a number of shallow riffles which have been colonised by <i>Ranunculus</i>. • Channel banks and margin have good vegetation cover. <p>Conservation actions:</p> <ul style="list-style-type: none"> • Create a corridor of natural riparian vegetation along both banks.

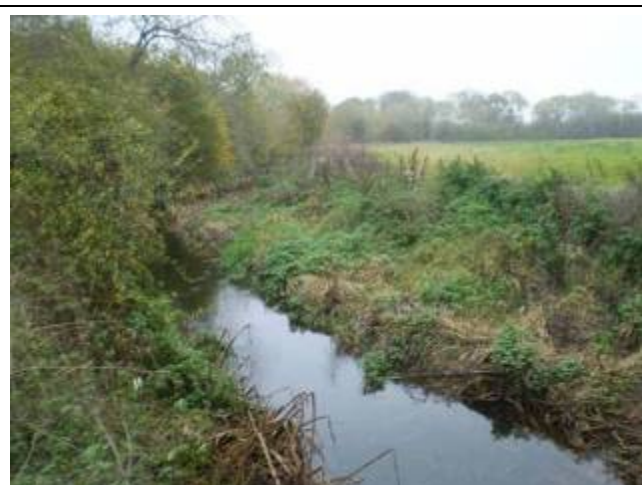
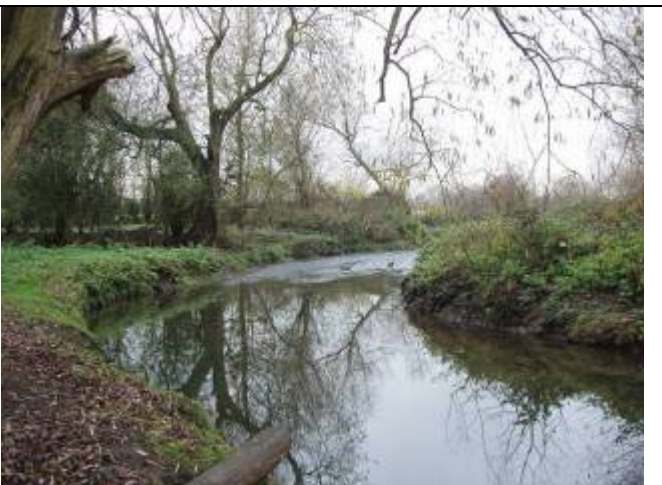
<p>Reach MEA015 Start NGR 423819 311368 End NGR 423368 311366</p> <p>Key features:</p> <ul style="list-style-type: none"> • Evidence of adjustment, through narrowing as a result of marginal sediment deposition and colonisation of deposits by vegetation. • Localised sediment deposition on the bed has created a number of shallow riffles which have been colonised by <i>Ranunculus</i>. • Channel banks and margin has good vegetation. <p>Conservation actions:</p> <ul style="list-style-type: none"> • Create a corridor of natural riparian vegetation along both banks. • Manage livestock access to the channel (there is currently a small drinking point on the right bank) either through fencing or by providing livestock operated drinkers.

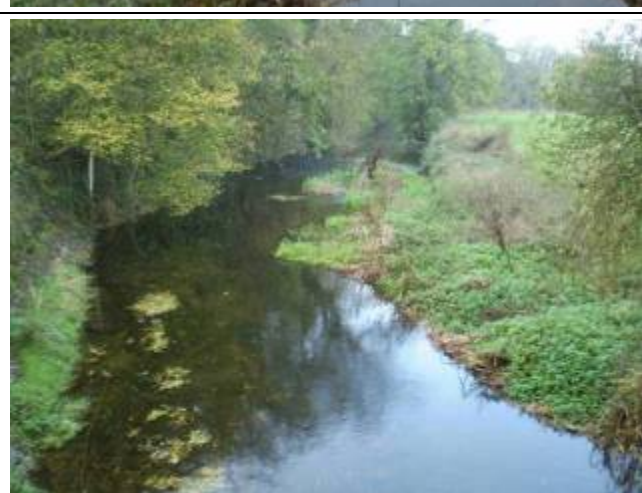
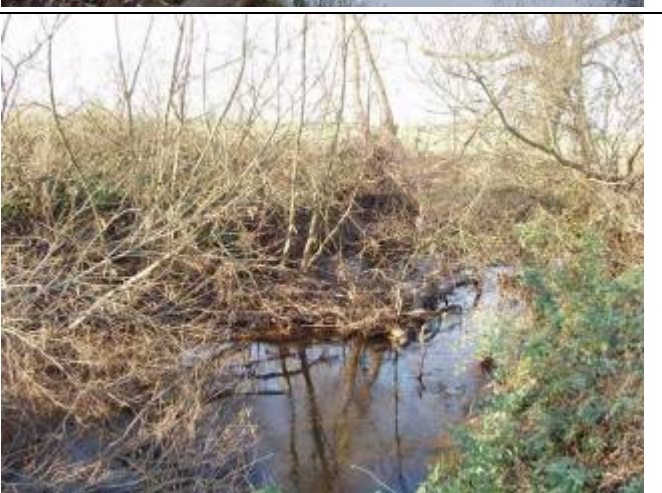
<p>Reach MEA018 Start NGR 412503 311167 End NGR 421419 311505</p> <p>Key features:</p> <ul style="list-style-type: none"> • Section of channel which is located along the left side of the valley. • Evidence of adjustment, through narrowing and localised sediment deposition on the bed which has created a number of shallow riffles. • Good supply of coarse woody debris that creates to flow diversity and microhabitat patches. <p>Conservation actions:</p> <ul style="list-style-type: none"> • Encourage development of natural riparian vegetation along the right bank.

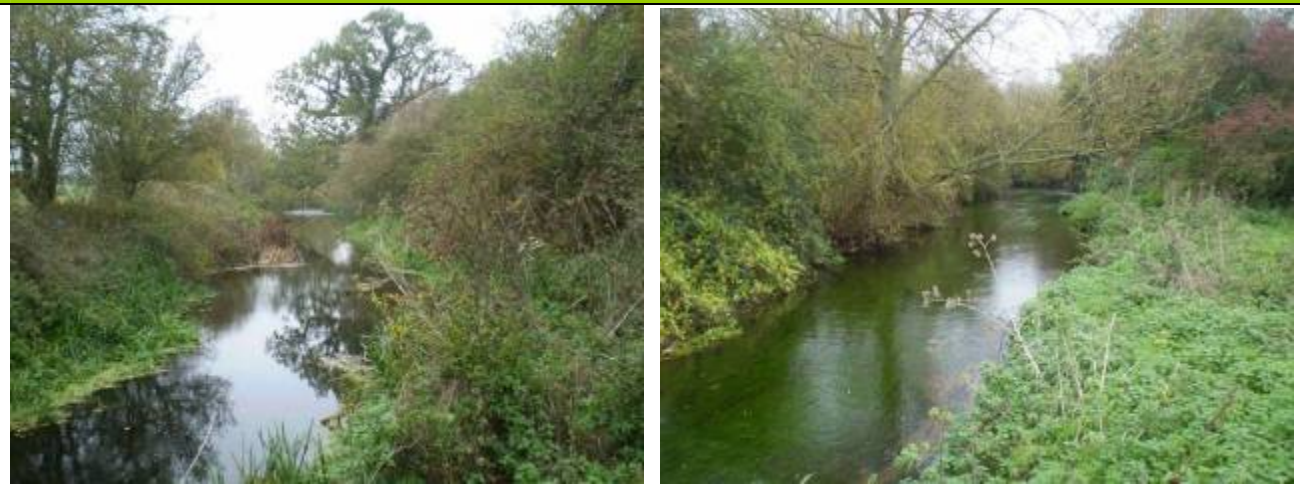
Description	Photographs	
<p>Reach MEA022 Start NGR 420229 312590 End NGR 419685 313057</p> <p>Key features:</p> <ul style="list-style-type: none"> • Located along the valley side in the upper part of the reach. • Has adjusted towards a more natural form through narrowing as a result of marginal sediment deposition and colonisation of deposits by vegetation. • Localised sediment deposition on the bed has created a number of shallow riffles which have been colonised by <i>Ranunculus</i>. • Channel banks and margins have good vegetation cover. • Good supply of coarse woody debris. <p>Conservation actions:</p> <ul style="list-style-type: none"> • While the riparian vegetation generally natural and diverse there are some gaps which could be filled.

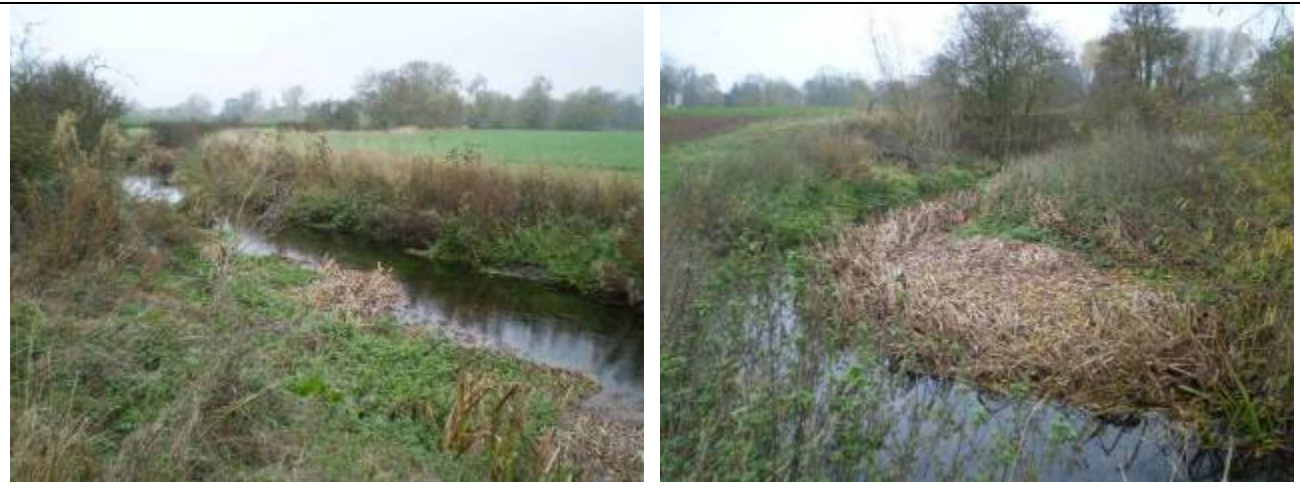
<p>Reach MEA023 Start NGR 419685 313057 End NGR 419814 313486</p> <p>Key features:</p> <ul style="list-style-type: none"> • Meandering section of river with a natural planform undergoing adjustment, through narrowing as a result of marginal sediment deposition and colonisation of deposits by vegetation. • The varied channel width has created varied flow velocities. • Channel banks and margins have good vegetation cover. <p>Conservation actions:</p> <ul style="list-style-type: none"> • The land along both banks is arable and the uncultivated margin is relatively narrow in places. The width of the uncultivated margin could be increased by restoring a strip of natural riparian vegetation at least 12m wide along both banks.

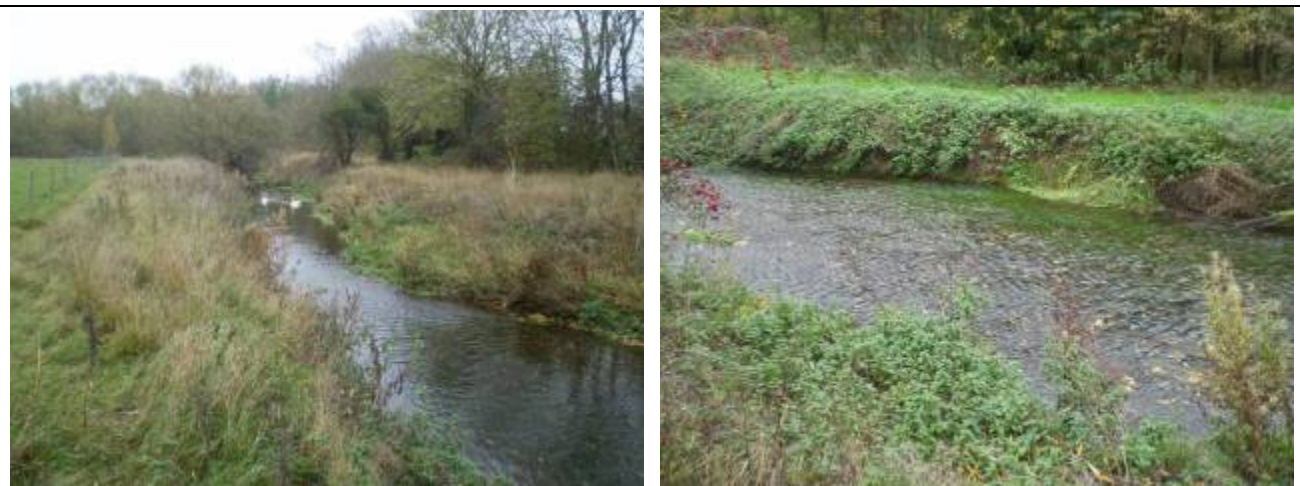
<p>Reach MEA025 Start NGR 419283 314020 End NGR 419528 314739</p> <p>Key features:</p> <ul style="list-style-type: none"> • Previously realigned section of river, which has a relatively straight planform with occasional bends. However, despite this modification the channel has a highly varied morphology. • Evidence of adjustment, through narrowing as a result of marginal sediment deposition and colonisation of deposits by vegetation. • Localised sediment deposition on the bed has created a number of shallow riffles which have been colonised by <i>Ranunculus</i>. • Channel banks and margins have good vegetation cover. <p>Conservation actions:</p> <ul style="list-style-type: none"> • The extent of natural riparian vegetation could be increased along the left bank.

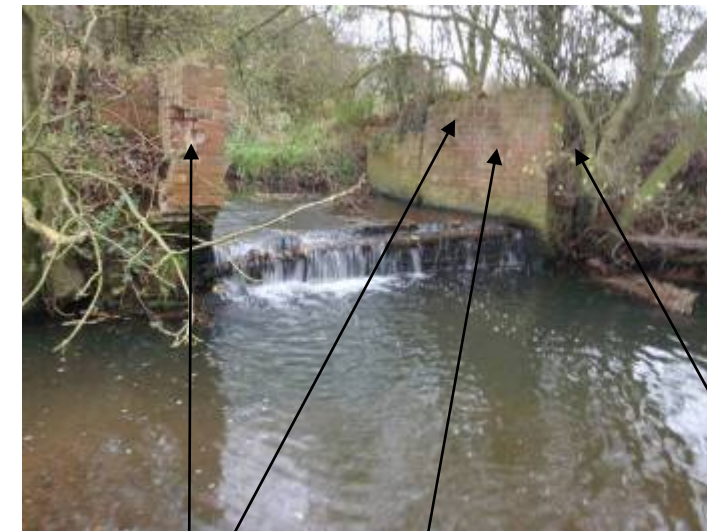
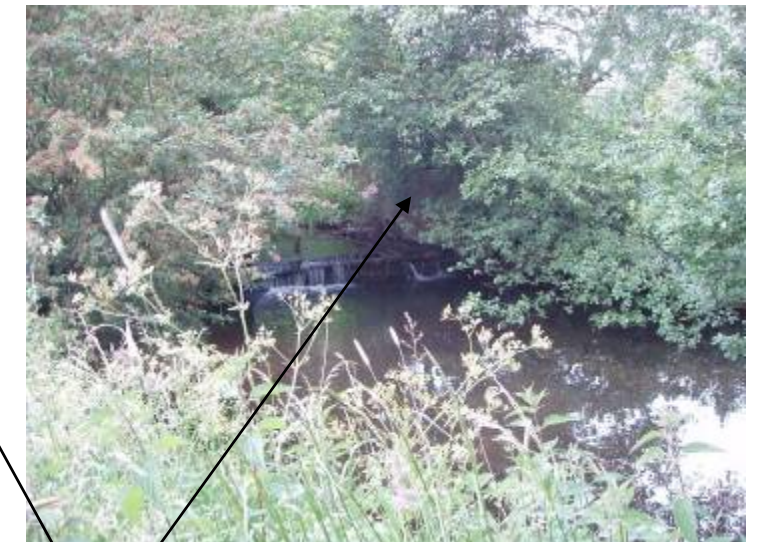
Action R6
Remove weir and associated walls along the banks.

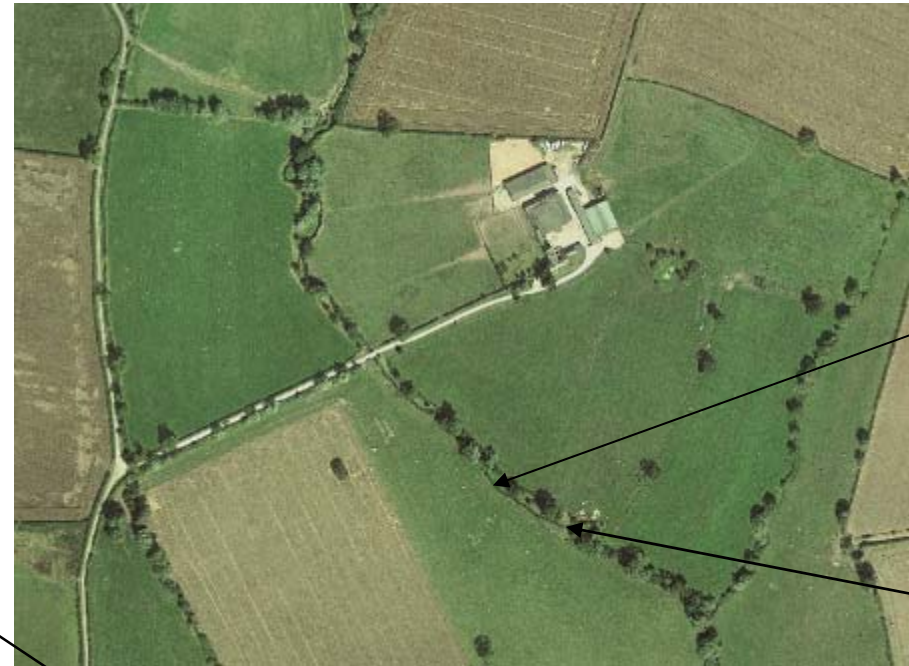
Action E2
 Create a corridor of natural riparian vegetation along (parallel to) both banks along the full length of the reach. This should ideally be at least 12m wide along both sides of the channel. Tree planting will be required and a way to control stock access until the riparian vegetation has established will be required.

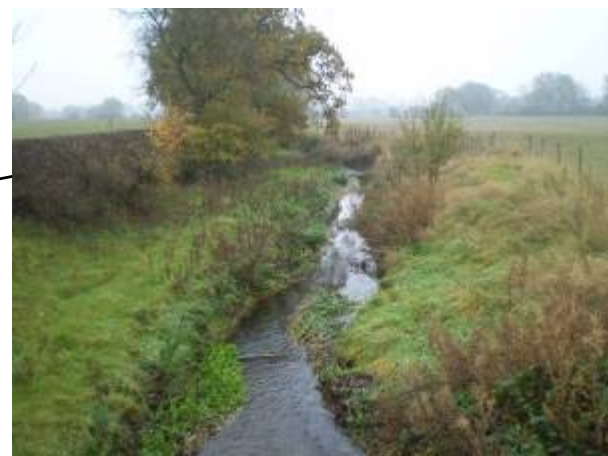
Below: An example of a section which has started to recover through natural adjustment:

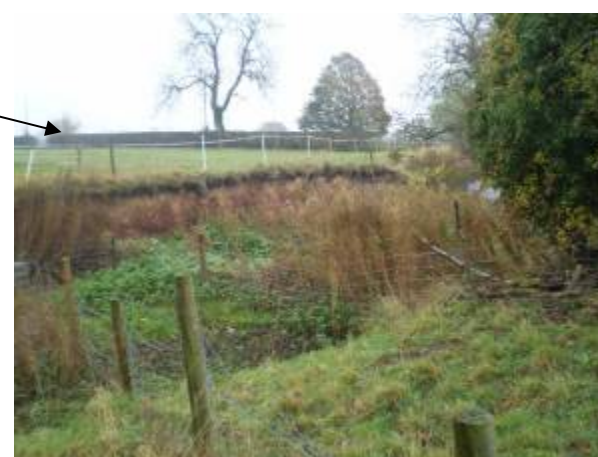
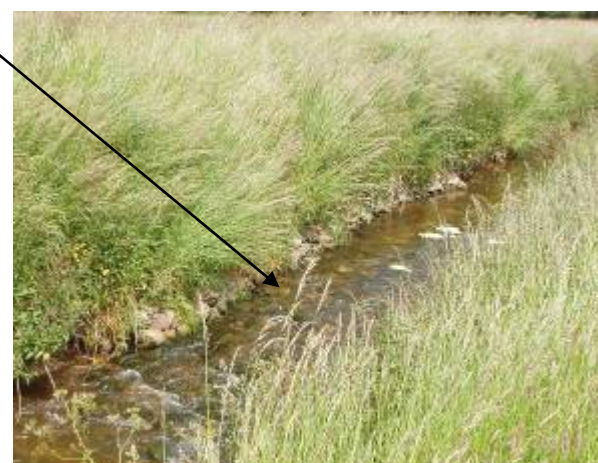
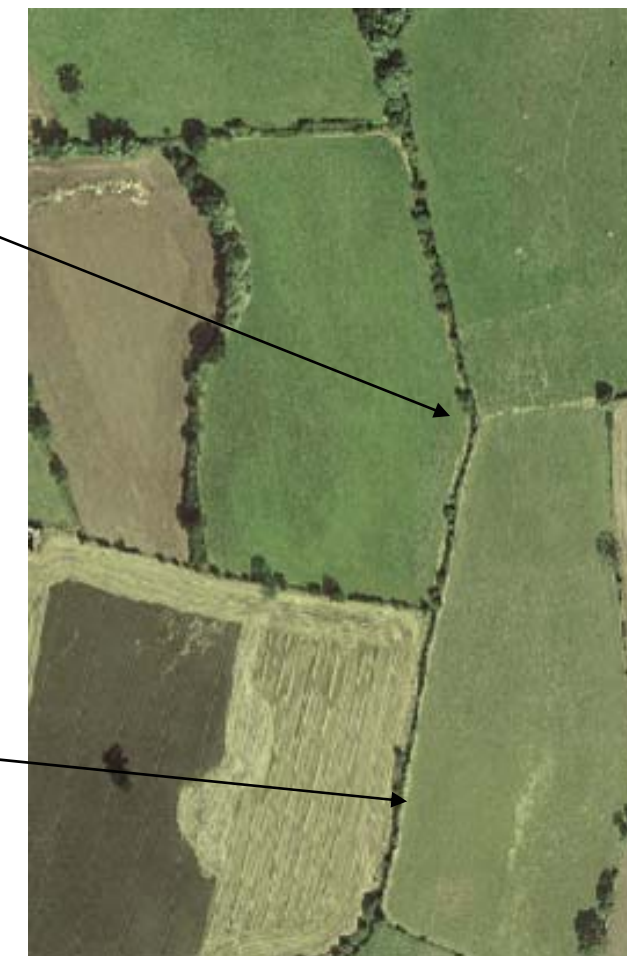
Action R2 and R4
Remove stone bank reinforcement and re-profile the banks to reduce the bank slope.

Action	Site specific details (refer also to Section 3)	Site specific benefits (refer also to Section 3)	Site specific constraints
Remove bank reinforcement and re-profile the banks	Remove the stone bank reinforcement along both banks in the middle section of the reach and re-profile the banks to reduce the bank slope.	Would restore natural bed (cobble/gravel) and bank (earth) conditions.	None Identified.
Improve the riparian corridor	Create a riparian corridor along both banks of the channel, including the re-profiled banks.	Would help to stabilise the banks of the channel, provide cover for fish and a source of woody debris.	Will require grazing to be restricted in the short to medium term, probably fencing set at least 12m back from the bank tops and therefore change in land management.

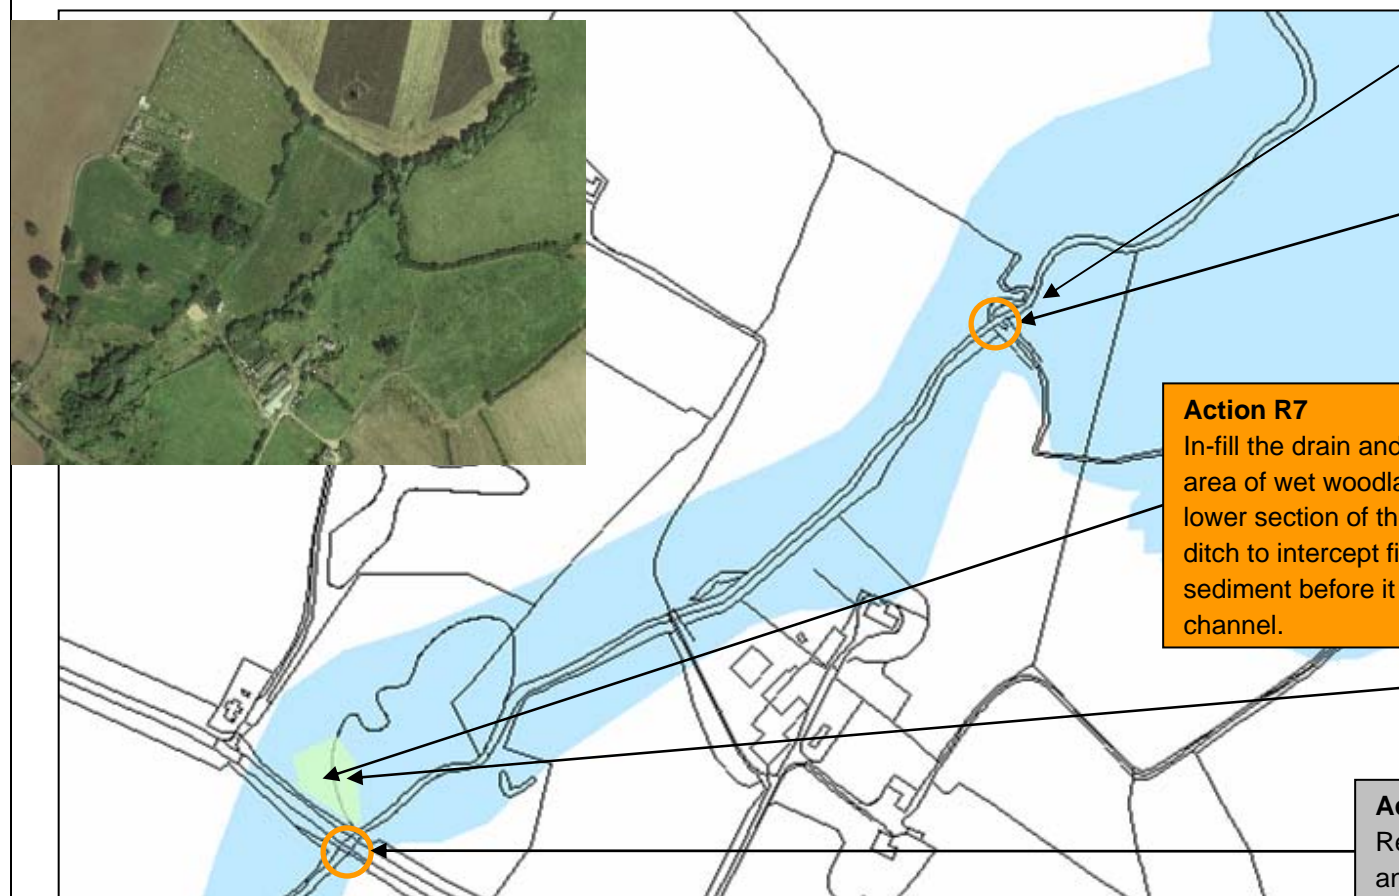
Action R2
Remove culvert and reinstate a natural section of tributary channel.

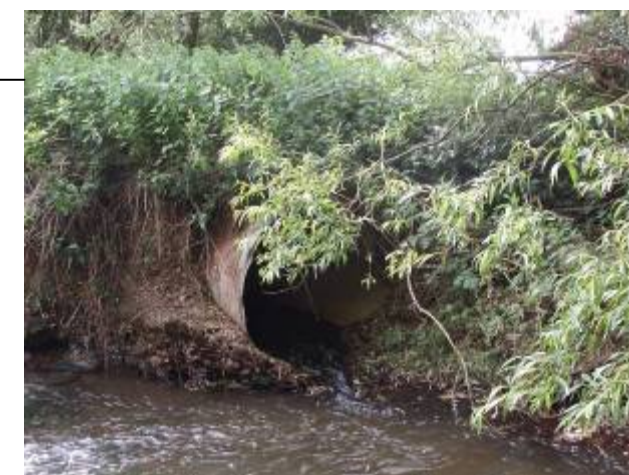
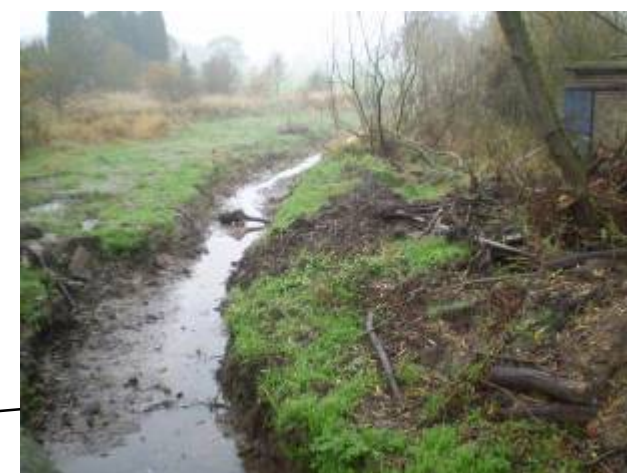
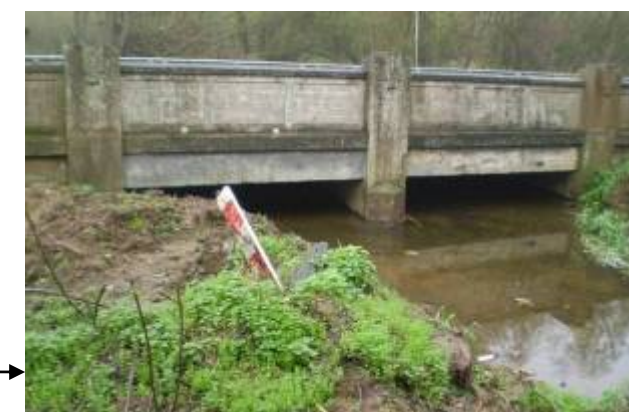
Action R7
In-fill the drain and plant an area of wet woodland at the lower section of the drainage ditch to intercept fine sediment before it enters the channel.

Action: Other
Review the need for sediment management with highway authority and develop an appropriate management strategy.

Action	Site specific details (refer also to Section 3)	Site specific benefits (refer also to Section 3)	Site specific constraints
Remove culvert	Remove culvert and reinstate a natural open channel section of tributary channel.	Prevents local scour.	Access to the culvert to undertake removal may be limited.
Create wet woodland	In-fill the lower section of the ditch and plant an area of wet woodland to intercept fine sediment.	Reduced fine sediment and diffuse pollution supply to the channel.	Would require change in land management along the channel margins.
Review sediment management	Review the need for sediment management with highway authority and develop an appropriate management strategy.	Ensures that maintenance activities are undertaken in a sympathetic manner.	The road bridge is very low and as a result blockage by sediment and woody debris is likely during floods.

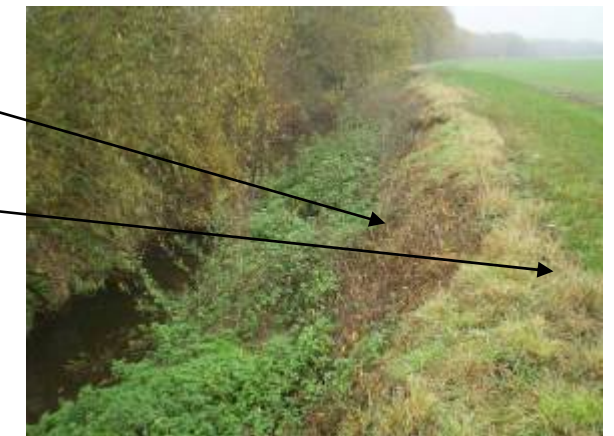
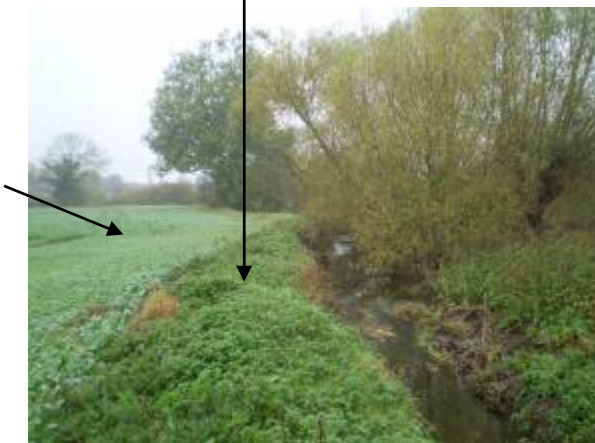
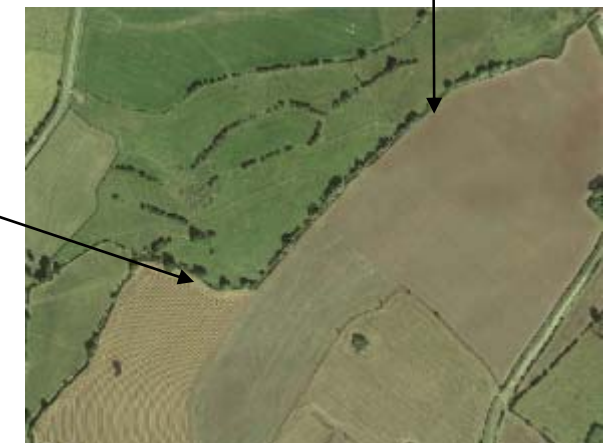
Action R3
Remove embankment to allow flood flows to dissipate uniformly over the bank.

Action E3
Create riparian corridor along the channel. As this is a low lying area which is at risk of flooding opportunities should be sought to maximise the extent of this area to prevent soil erosion during floods.

Action	Site specific details (refer also to Section 3)	Site specific benefits (refer also to Section 3)	Site specific constraints
Re-profile left bank	Reduce the slope of the left bank to create a wider channel with a gentle bank slope.	Improve the stability of the left bank and the capacity of the channel to contain flood water.	Would require a change in land management along the left bank.
Remove embankment	Remove embankment along the top of the left bank.	Restore natural floodplain connectivity.	Would increase the likelihood and frequency of flooding of the field, but reduce any ponding behind current embankment.
Create riparian corridor	Reinstate natural riparian vegetation along the top of the left bank in a strip at ideally least 12m in width. This could involve either natural adjustment or tree planting.	Would reduce the risk of erosion of the banks and the floodplain along the channel margin during floods.	Would require a change in land management along the left bank.

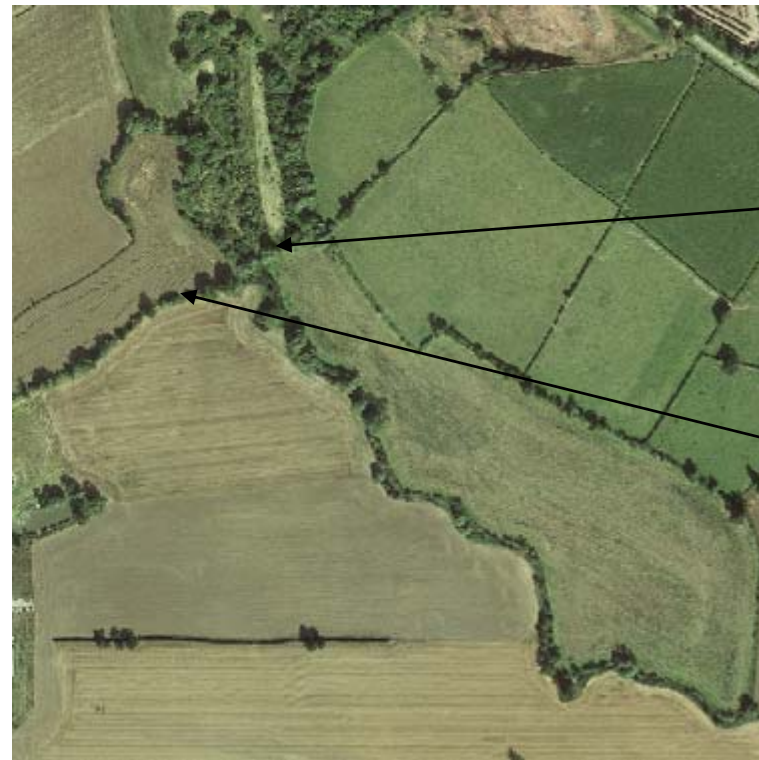
Action R7
Create areas of wet woodland near the confluence of the open drains (ditches) to the left and right of the channel and divert discharge from drains through this woodland.

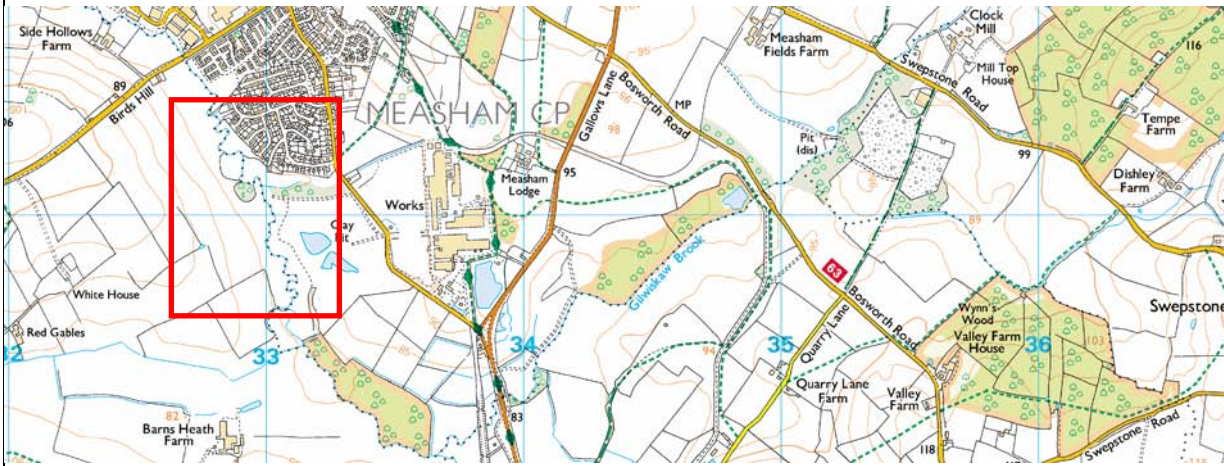
River Mease at Measham (South)

- The River Mease is set within a relatively broad valley with floodplain located along both banks.
- Land use along the left bank is dominated by arable while the land to the right is used for grazed pasture.
- The channel has a meandering planform and a relatively varied morphology, which reflects adjustment following past deepening. The banks are of variable slope, the channel width varies and flow velocities are variable.
