River Mease SSSI/SAC Restoration Plan

Client: Natural England
 Project: River Mease SSSI/SAC Restoration Job No: B1753400
 Document Title: River Mease SSSI/SAC Restoration Plan

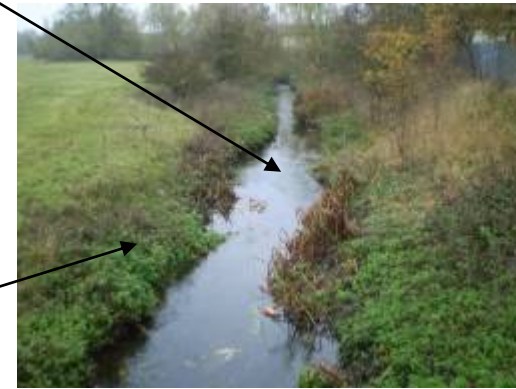
Action R5
Reinstate coarse (gravel) bed material to create riffles in selected locations.

Action R1
Introduce woody debris along reach.

Action	Site specific details (refer also to Section 3)	Site specific benefits (refer also to Section 3)	Site specific constraints
Re-profile banks and also introduce woody debris and gravel (riffle creation).	Re-profile both banks along the full length of the reach to create a variety of bank profiles and also introduce woody debris and gravels	Would allow a varied channel morphology to be created and provide variations in flow velocities.	Would require some change in land management along the channel margins. Increased woody debris may increase flood risk to properties. Further feasibility work would be required.
Improve the riparian corridor	Create a riparian corridor along both banks of the channel, including the re-profiled banks.	Would help to stabilise the banks of the channel, provide cover for fish and a source of woody debris.	Would require some change in land management along the channel margins, and change in land use on left bank.

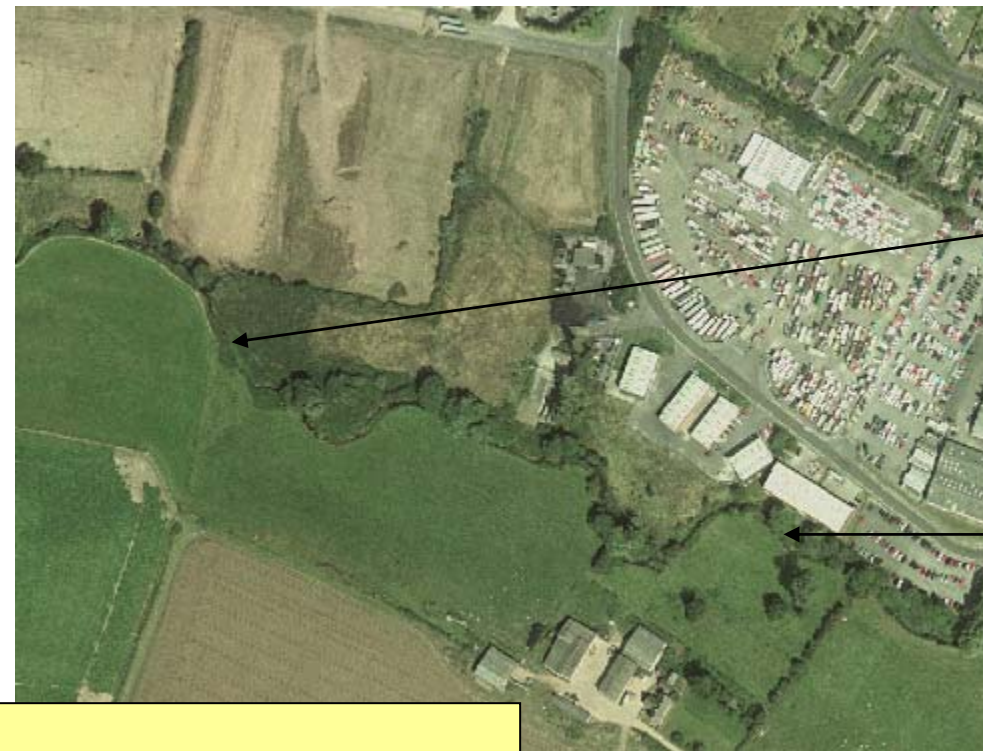
Action E3
Create a riparian corridor along (parallel to) both banks along the full length of the reach. This should be at least 12m wide.

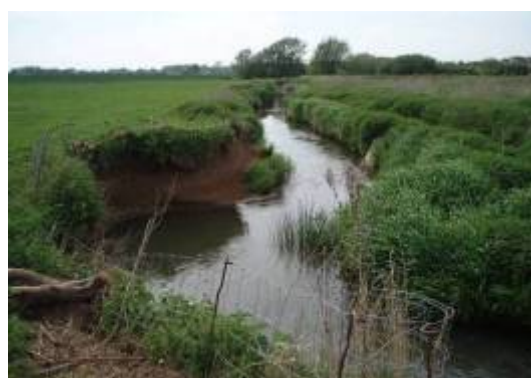
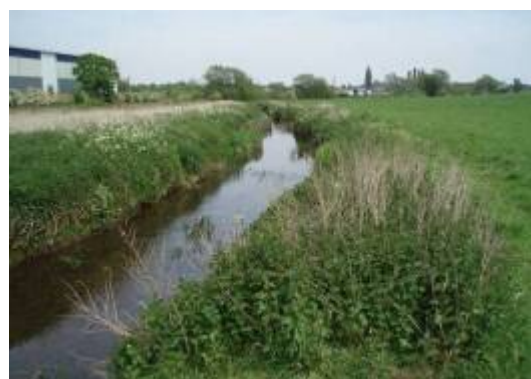
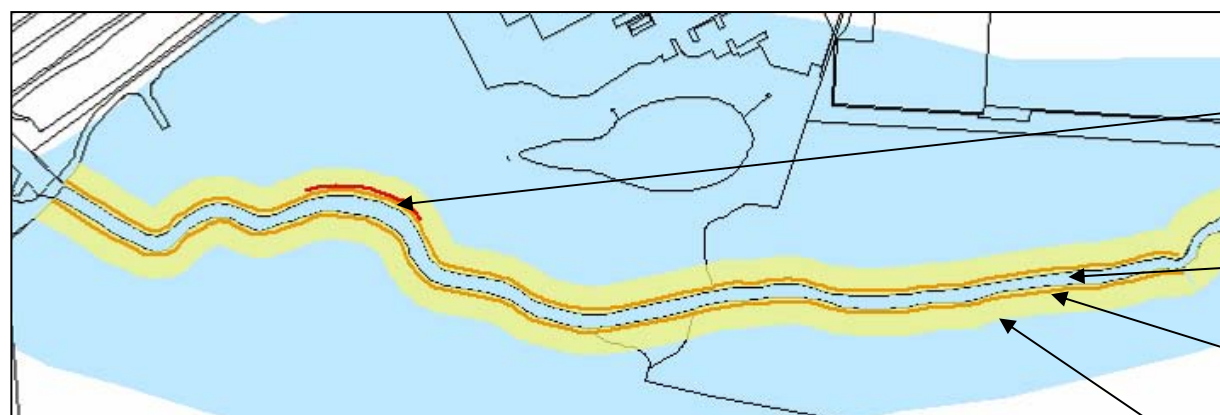
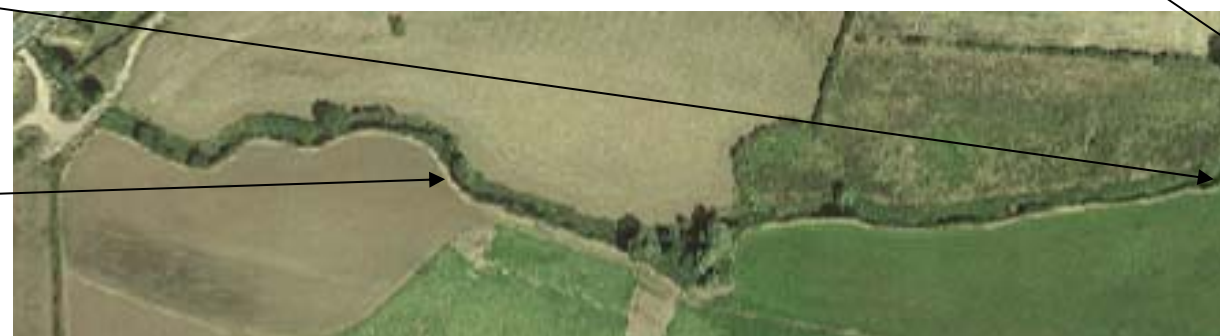
Action R2
Remove rock armour bank protection.

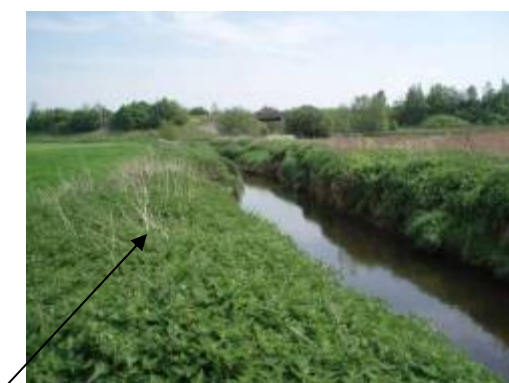
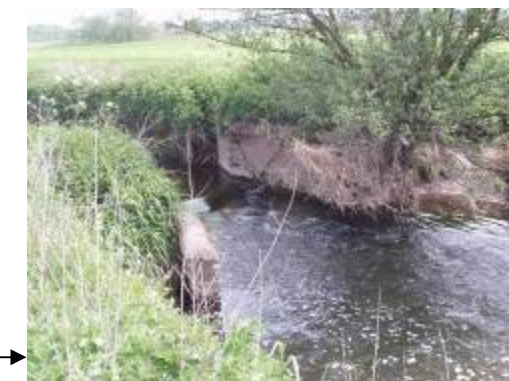
Action E3
Create a riparian corridor along both banks along the full length of the reach. This should be ideally at least 12m wide along both sides of the channel. The riparian corridor should include the inside of the meanders in the channel to reduce the risk of soil erosion.

Action R6
Remove weir.

Action	Site specific details (refer also to Section 3)	Site specific benefits (refer also to Section 3)	Site specific constraints
Re-profile banks; add woody debris and gravels (riffle creation).	Re-profile both banks along the full length of the reach to create a variety of bank profiles especially on inside banks of meanders. Add woody debris and gravels to increase the diversity of the channel.	Would allow a varied channel morphology to be created and provide variations in flow velocities.	Would require some change in land management along the channel.
Create an area of wetland	Create an area of wetland in the floodplain and also widening the lower section of Saltersford Brook.	Would help to attenuate flood flows and help trap fine sediment supplied by drainage from the A42, the sewage works and Saltersford Brook	Would require some change in land management to the right of the river. Look at land agreements to facilitate this.

Remove weir	Remove weir and associated embankments on either side of structure.	Would allow unrestricted movement of fish. Would lower water levels upstream and increase variation in flow velocities.	Reduced water levels may lead to localised bank instability. Improvements to the riparian zone would help stabilise the channel
Create a corridor of riparian vegetation.	Create a riparian corridor along both banks of the channel, including the re-profiled banks.	Would involve preventing livestock access to the channel so would reduce the impact of poaching.	Would require some change in land management along the channel, including appropriate grazing regime

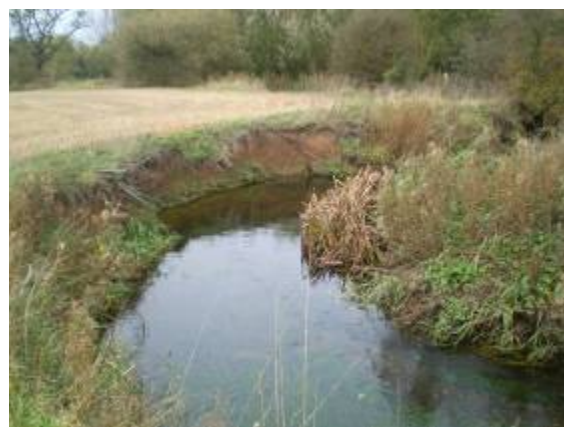
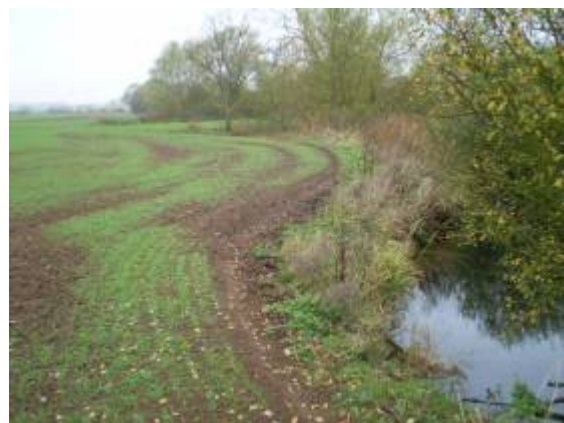
- The land to the left of the river channel is tilled up to the bank top including areas of floodplain on the insides of tight meanders (although the degree to which this occurs varies between years) (see aerial photographs below). Cultivating the land on the inside of meanders in this manner increases the risk of soil erosion during floods as flood water often cuts across the inside of the bends.
- The left bank is subject to localised erosion which appears to be exacerbated by the proximity of ploughing and the absence of natural riparian vegetation.

Action R1 and R5
Introduce woody debris and gravels into channel in selected locations.

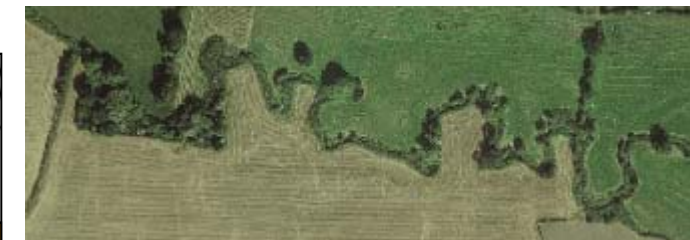
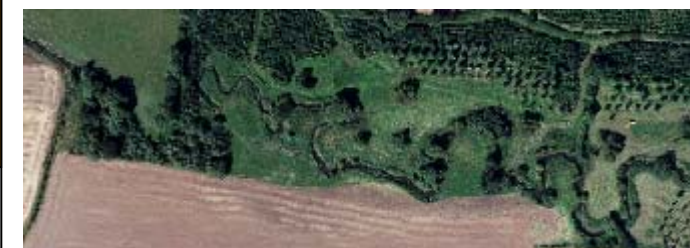
Action E3
Create riparian corridor along both banks along the full length of the reach. This should be at least 12m wide along both sides of the channel. The riparian corridor should include the inside of the meanders in the channel to reduce the risk of soil erosion. The current situation and the proposed approach are shown in the aerial photograph above.

Action	Site specific details (refer also to Section 3)	Site specific benefits (refer also to Section 3)	Site specific constraints
Re-profile banks; add woody debris and gravels (riffle creation).	Re-profile banks on inside of meanders. Add woody debris and gravels to increase the diversity of the channel.	Would allow a varied channel morphology to be created and provide variations in flow velocities.	Would require some change in land management along the channel.
Create a corridor of riparian vegetation	Create a riparian corridor along both banks of the channel.	Would help to stabilise the banks of the channel, provide cover for fish and a source of woody debris.	Would require some change in land management along the river corridor, including appropriate grazing regime.

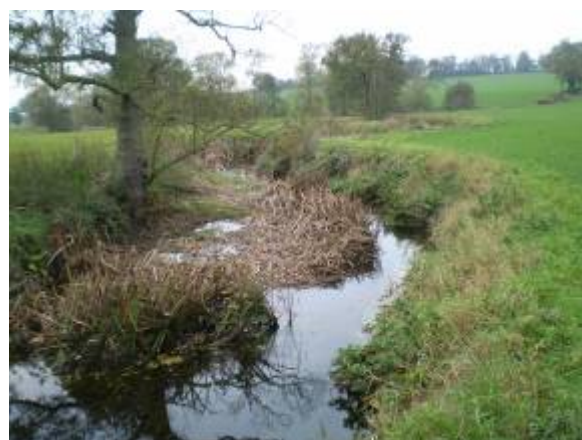
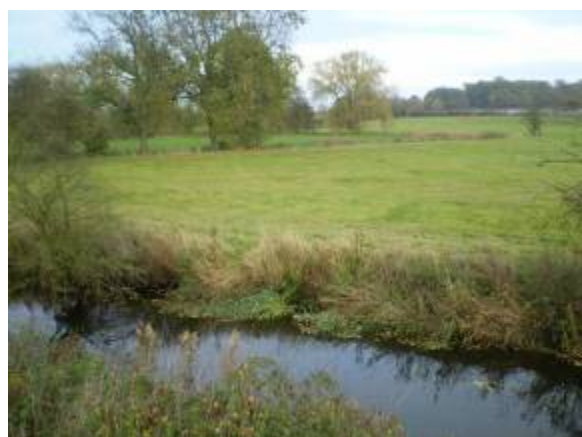
Action E3
Create a riparian corridor of along both banks along the full length of the reach. This should be ideally at least 12m wide along both sides of the channel. The riparian corridor should include the inside of the meanders in the channel to reduce the risk of soil erosion.

Action R4
Re-profile banks to create a variety of bank profiles along the full length of the reach.

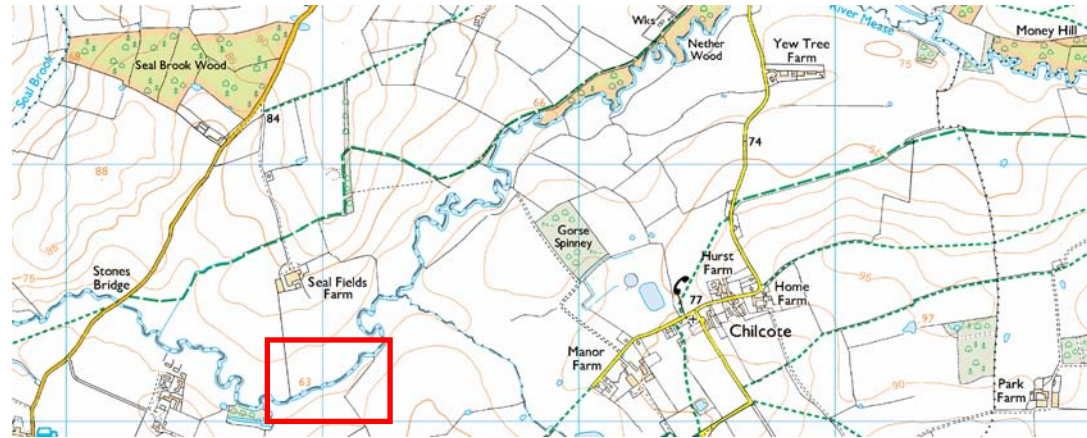
- The land along both banks of the river channel is tilled close to the bank top and the uncultivated margin is very uniform.
- The channel has a very straight planform which is atypical of the river in this part of the catchment.
- The flow is very uniform and deep (glide) throughout.
- Tree lining of the channel is absent in this reach.

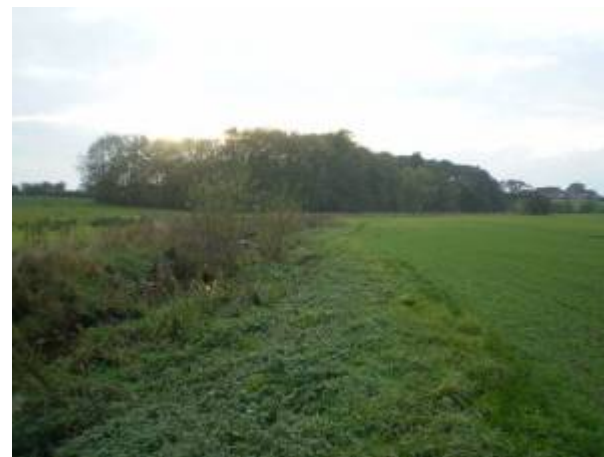
Action E2

Improve the riparian vegetation along (parallel to) both banks along the full length of the reach. This should be at least 12m wide along both sides of the channel.

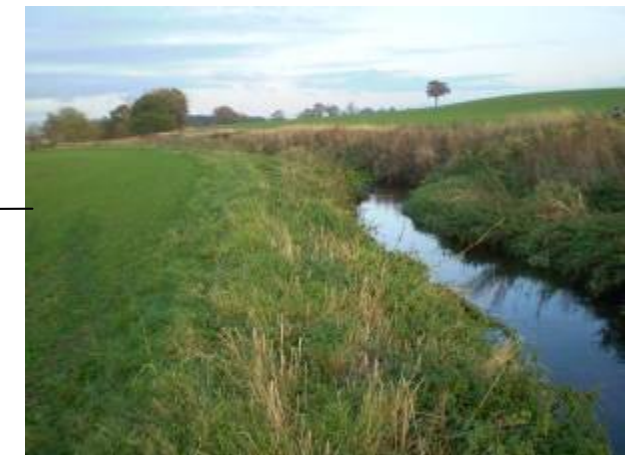
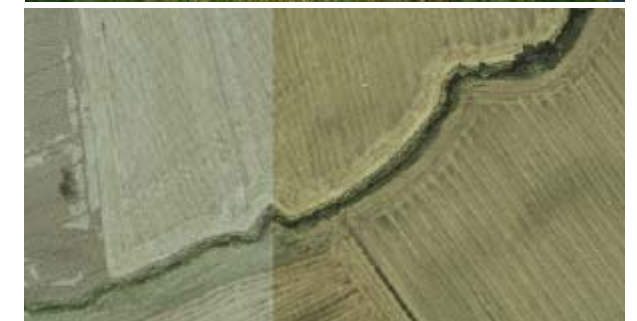
Action R1
Introduce woody debris into channel in selected locations.

Action R5
Reinstate coarse (gravel) bed material to create riffles in selected locations.

Action	Site specific details (refer also to Section 3)	Site specific benefits (refer also to Section 3)	Site specific constraints
Re-profile banks	Re-profile both banks along the full length of the reach to create a variety of bank profiles and a sinuous low flow channel.	Would allow a sinuous channel course to be created and also opportunities to increase flow velocity by narrowing the channel.	Would require some change in land management along the river banks.
Add woody debris to channel	Flow is very uniform along this reach.	Increased diversity of flow patterns and velocities, Encourages a varied bed to develop by erosion and deposition.	None identified.
Reinstate coarse bed (riffle creation)	Flow is very uniform along this reach.	Increased diversity of flow patterns and velocities	May raise water levels upstream. May reduce effectiveness of field drains.
Improve the riparian vegetation	Create a riparian corridor along both banks of the channel, including the re-profiled banks.	Would help to stabilise the banks of the channel, provide cover for fish and a source of woody debris.	Would require some change in land management along the river corridor.

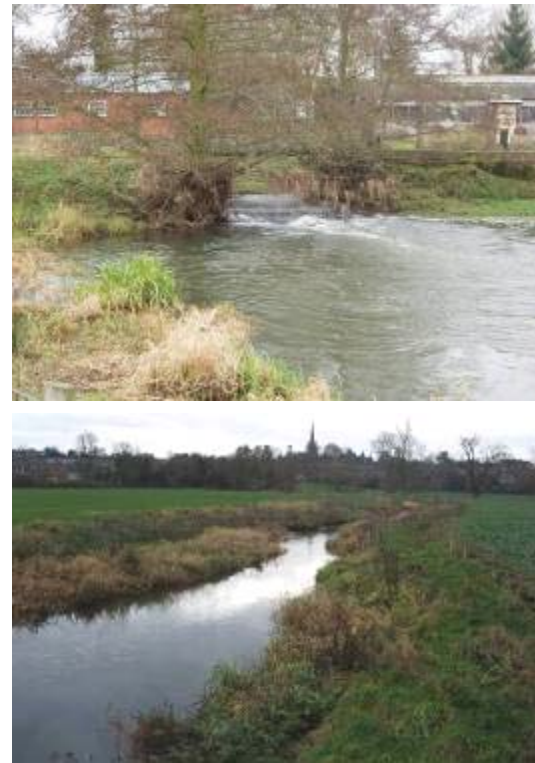
Action R6
Remove weir.

Action R5
Reinstate coarse (gravel) bed material to create riffles in selected locations.

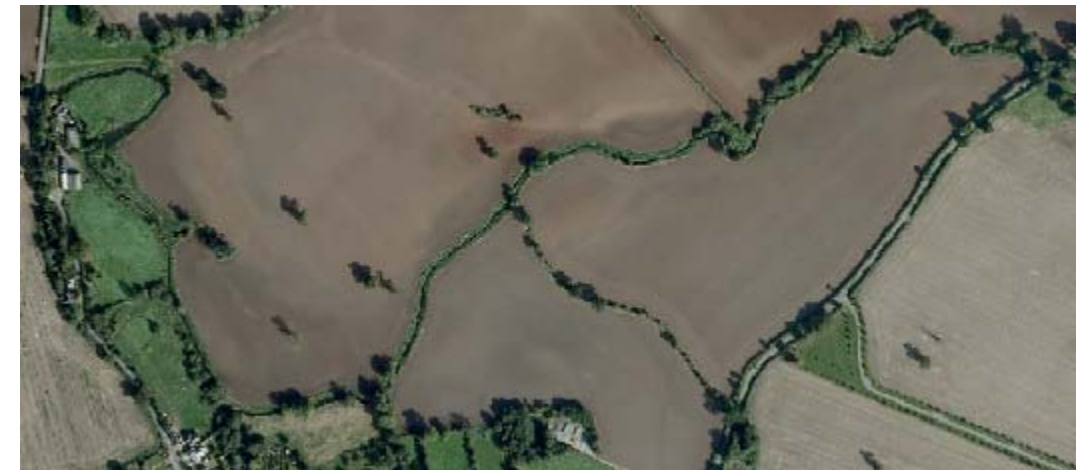
Action E3
Create a riparian corridor along both banks along the full length of the reach. This should be ideally at least 12m wide along both sides of the channel.

Action R1
Introduce woody debris into channel in selected locations along the reach.

Action	Site specific details (refer also to Section 3)	Site specific benefits (refer also to Section 3)	Site specific constraints
Remove weir	Remove weir and associated embankments on either side of structure.	Would allow unrestricted movement of fish. Would lower water levels upstream and increase variation in flow velocities creating a more dynamic natural bed	Reduced water levels may lead to localised bank instability. However, improvements to the riparian zone would help stabilise the channel reduce. A separate feasibility report is being produced.
Add woody debris to channel and mixed river gravels	Flow is very uniform along this reach.	Increased diversity of flow patterns and velocities encourages a varied bed to develop by erosion and deposition.	None identified.
Reinstate coarse bed (riffle creation)	Flow is very uniform along this reach.	Increased diversity of flow patterns and velocities	Would only be effective if weir removal is undertaken.

Create a riparian corridor	Create a riparian corridor along both banks of the channel, including the re-profiled banks.	Would help to stabilise the banks of the channel, provide cover for fish and a source of woody debris.	Would require some change in land management along the river corridor, including appropriate grazing regime.

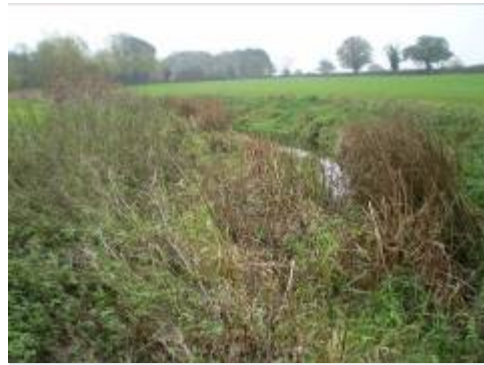
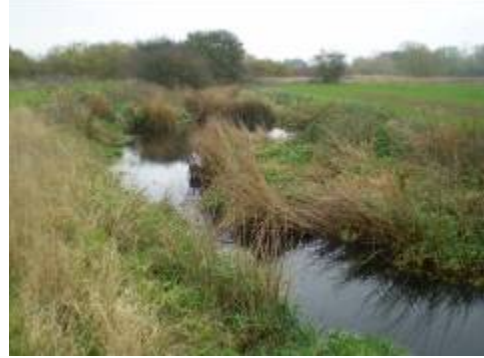
Action E3
Create a riparian corridor along both banks along the full length of the reach. This should be ideally at least 12m wide along both sides of the channel.

Action R4
Re-profile banks to create a variety of bank profiles along the full length of the reach.

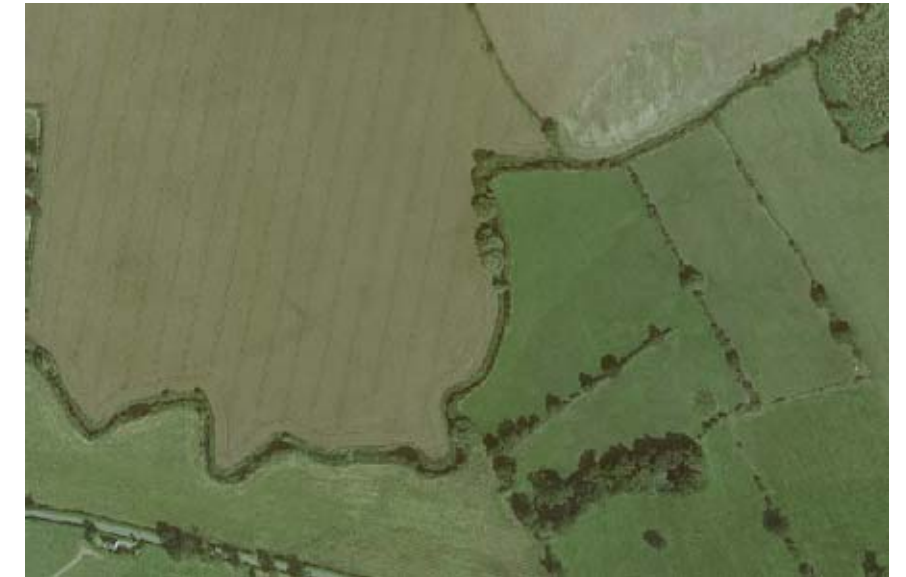
Action R5
Reinstate coarse (gravel) bed material to create riffles in selected locations.

Action	Site specific details (refer also to Section 3)	Site specific benefits (refer also to Section 3)	Site specific constraints
Re-profile banks	Re-profile both banks along the full length of the reach to create a variety of bank profiles and a sinuous low flow channel.	Would allow a sinuous channel course to be created and also opportunities to increase flow velocity by narrowing the channel.	Would require some change in land management along the river corridor.
Add woody debris to channel	Flow is very uniform along this reach.	Increased diversity of flow patterns and velocities encourages a varied bed to develop by erosion and deposition.	None identified.
Reinstate coarse bed (riffle creation)	Flow is very uniform, slow and deep along this reach and this appears to have encouraged the growth of dense beds of in-channel vegetation.	Increased diversity of flow patterns and velocities	May raise water levels upstream in certain flow conditions. May reduce effectiveness of field drains.

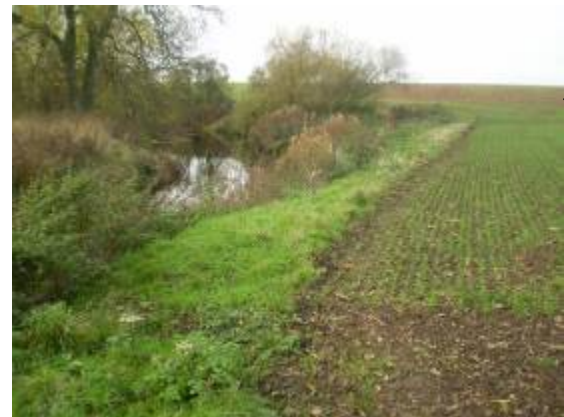
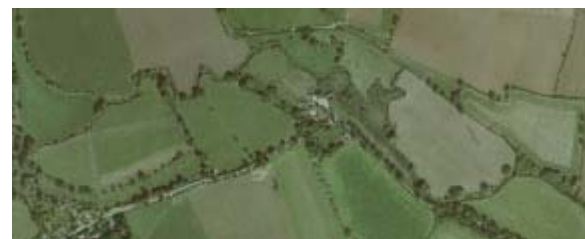
Action R5
Reinstate coarse (gravel) bed material to create riffles in selected locations.

Action R4
Re-profile banks to create a variety of bank profiles.

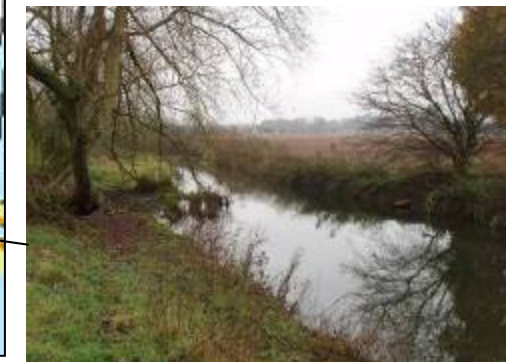
Action R1
Introduce woody debris into channel in selected locations.

Action E3
Create a riparian corridor along the right bank. This should be ideally at least 12m wide along both sides of the channel.

Action	Site specific details (refer also to Section 3)	Site specific benefits (refer also to Section 3)	Site specific constraints
Re-profile banks	Re-profile both banks along the full length of the reach to create a variety of bank profiles and a sinuous low flow channel.	Would allow a sinuous channel course to be created and also opportunities to increase flow velocity by narrowing the channel.	Would require some change in land management along the river corridor.
Add woody debris to channel	Flow is very uniform along this reach.	Increased diversity of flow patterns and velocities encourages a varied bed to develop by erosion and deposition.	None identified.
Reinstate coarse bed (riffle creation)	Flow is uniform, slow and deep along this reach and this appears to have encouraged the growth of dense beds of in-channel vegetation.	Increased diversity of flow patterns and velocities	May raise water levels upstream in certain flow conditions. May reduce effectiveness of field drains.

Create a riparian corridor	Create a riparian corridor along the banks of the channel, including the re-profiled banks.	Would help to prevent sediment release from field runoff and also provide cover for fish and a source of woody debris.	Would require some change in land management along the river corridor, including appropriate grazing regime.

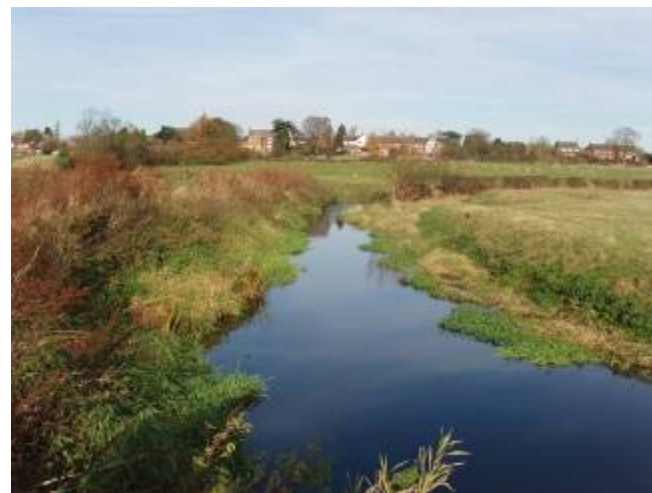
Action E2
 Improve the riparian vegetation along (parallel to) both banks along the full length of the reach. This should be ideally at least 12m wide along both sides of the channel.

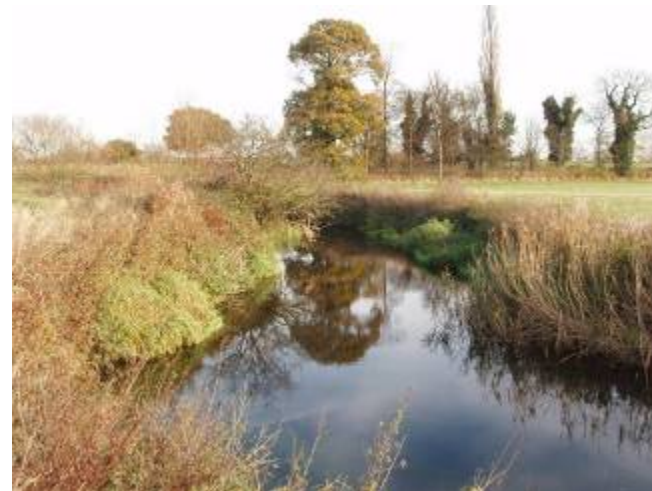
The photograph below illustrates a section of the reach which shows good tree cover.

Action	Sites specific details (refer also to Section 3)	Site specific benefits (refer also to Section 3)	Site specific constraints
Improve the riparian vegetation	Create a riparian corridor along both banks of the channel.	Would help to prevent sediment release from field runoff and also provide cover for fish and a source of woody debris enabling further adjustment of the channel morphology over time.	Would require some change in land management along the river corridor, including appropriate grazing regime.

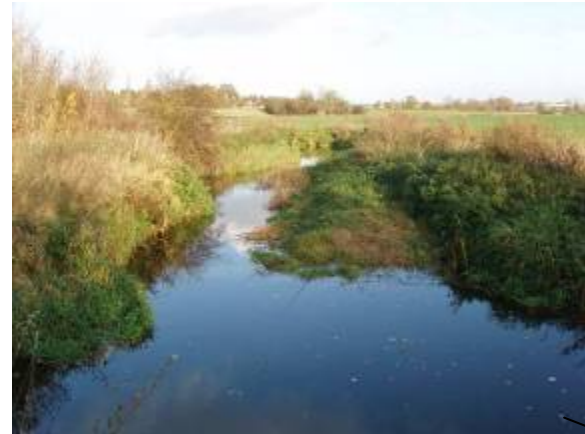
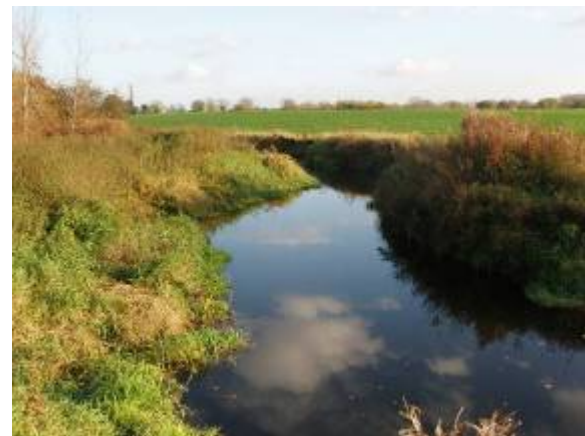
Action E3
Create a riparian corridor along the left bank. This should be ideally at least 12m wide along both sides of the channel.

Action	Sites specific details (refer also to Section 3)	Site specific benefits (refer also to Section 3)	Site specific constraints
Create a riparian corridor	Create a riparian corridor along the left bank of the channel.	Would help to prevent sediment release from field runoff and also provide cover for fish and a source of woody debris enabling further adjustment of the channel morphology over time.	Would require some change in land management along the left bank.

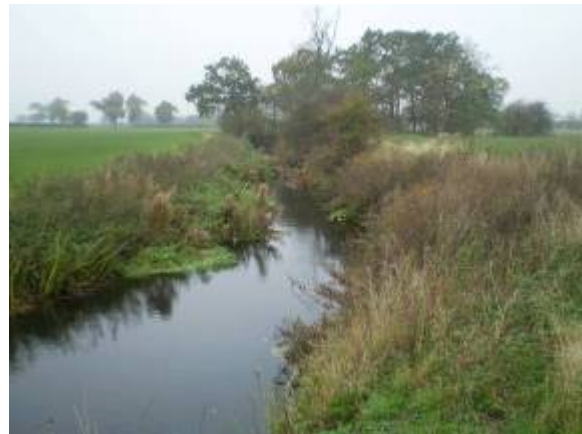
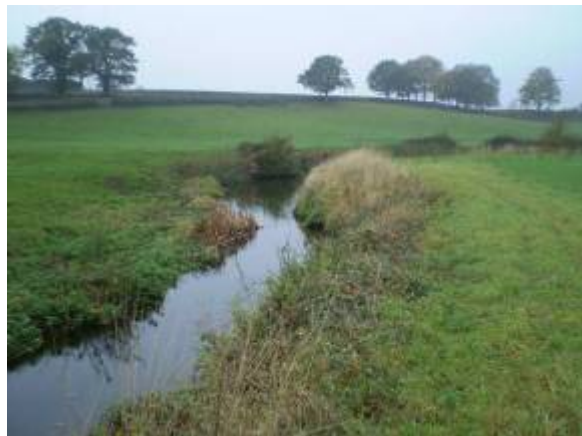
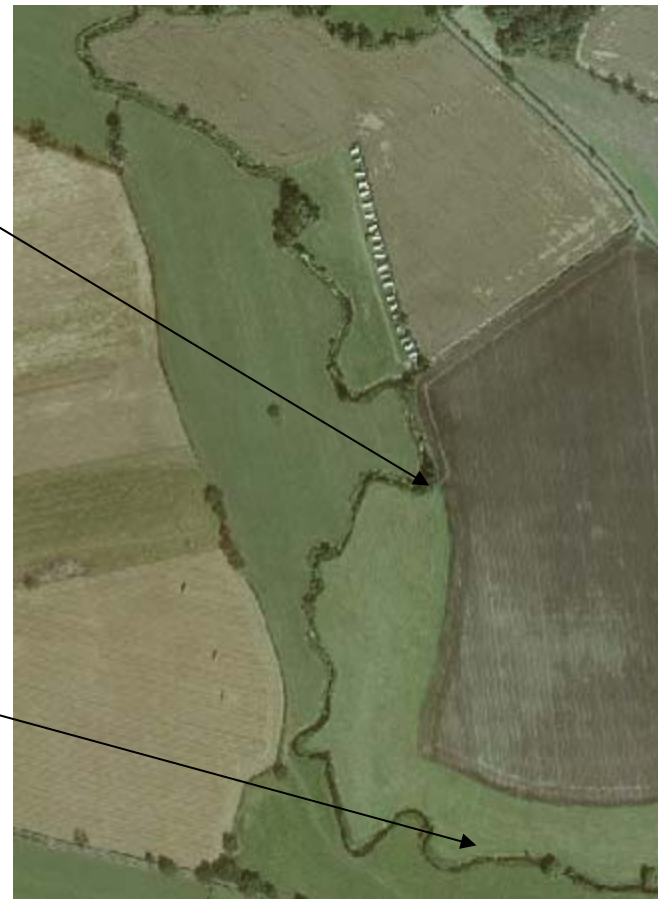
Action R4
Re-profile banks to create a variety of bank profiles along the full length of the reach.

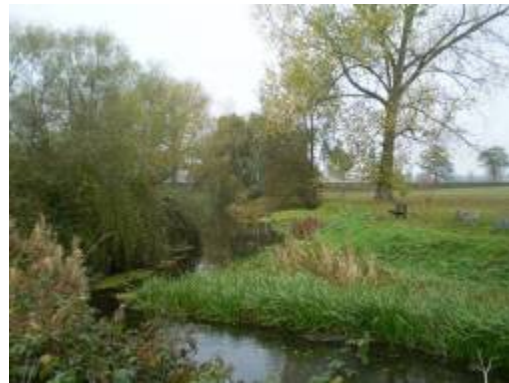
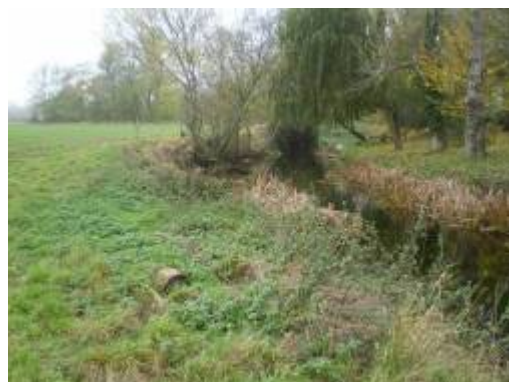
- The riparian zone to the left of the river lacks trees and is very narrow in places as ploughing occurs close to the bank top (narrow uncultivated margin).
- While there are trees present along the right bank, these are actively managed and relatively scattered and the ground vegetation is managed by mowing along the bank tops. This reduces the amount of wood debris supply and the degree of channel cover provided by trees.

Action E3
Create a riparian corridor along both banks. This should be ideally at least 12m wide along both sides of the channel.

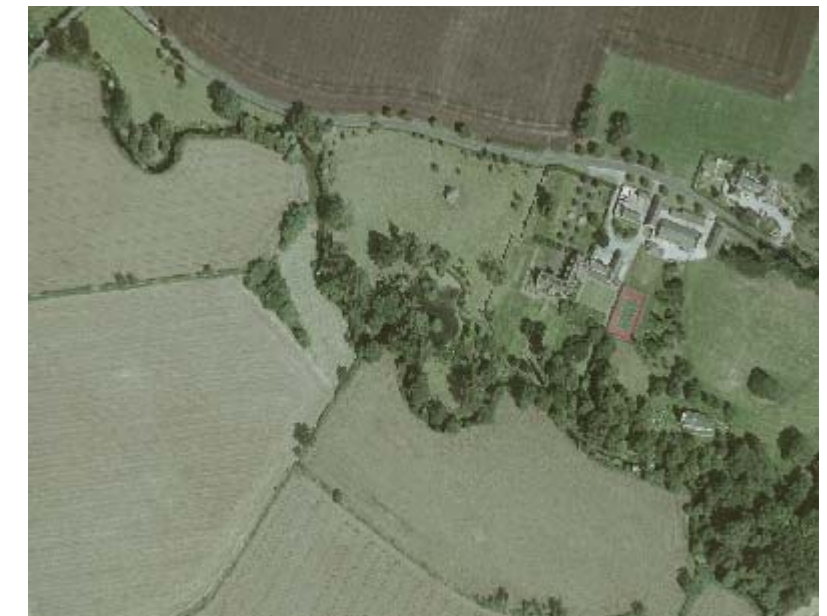
Action	Sites specific details (refer also to Section 3)	Site specific benefits (refer also to Section 3)	Site specific constraints
Create a riparian corridor	Create a riparian corridor along both banks of the channel.	Would help to prevent sediment release from field runoff and also provide cover for fish and a source of woody debris enabling further adjustment of the channel morphology over time.	Would require some change in land management along the river corridor, including fencing where land is grazed. Croxall Hall is Grade 2 Listed building. Riparian improvement proposals must be sensitive to the landscape and historic context of the site. The grounds are currently maintained for the benefit of wildlife and as such major improvements in this area may not be necessary.
