Lichfield District Council

Open Space Assessment 2016

November 2016

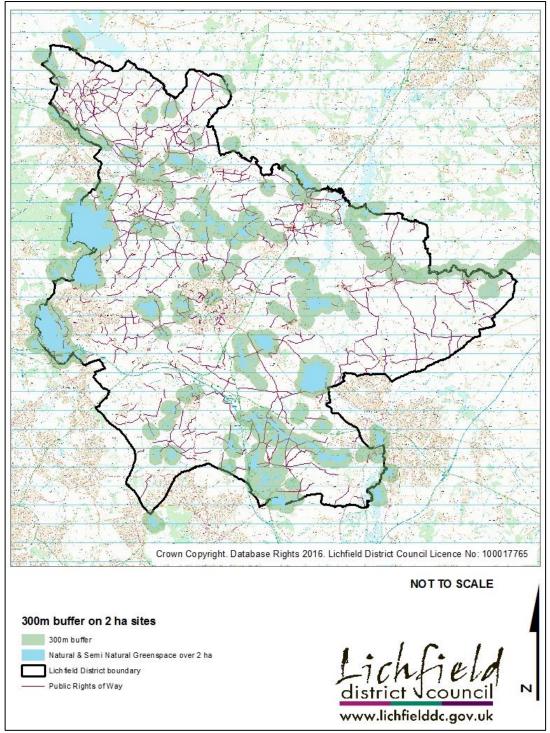
Map 5.2 Natural and Semi Natural Green Space over 2ha with 300m buffer

Large areas of the District have limited accessibility to natural and semi natural greenspace of 2 ha or more. This is evident when a 300m accessibility buffer is applied.

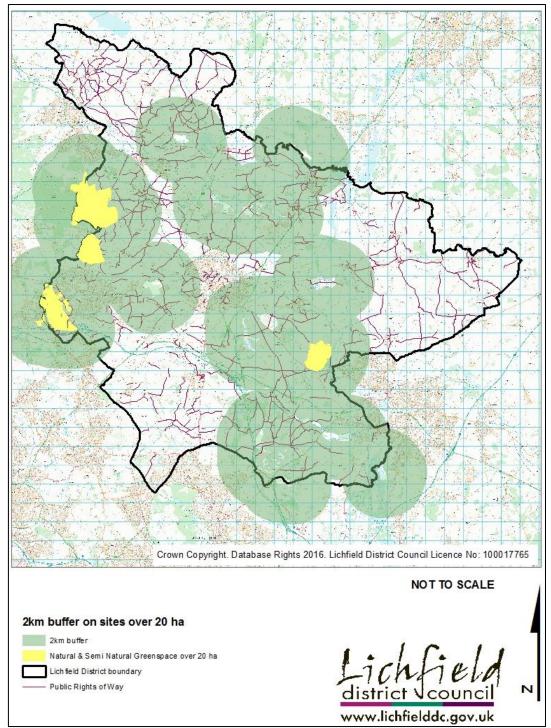
Map 5.3 Natural and Semi Natural Green Space over 20ha with 2km buffer

There are 17 sites identified within the District that are 20 ha or more. When the 2km buffer is applied to existing sites, a large proportion of the District's population has access to this size of natural and semi natural greenspace with the exception of areas around Shenstone and Stonnall to the south, the rural eastern part of the District and areas to the north around Colton and Hamstall Ridware.

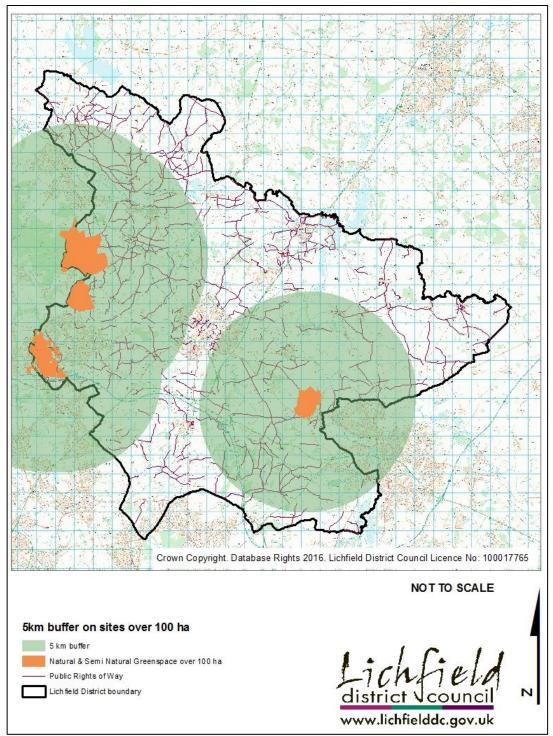
Map 5.4 Natural and Semi Natural Green Space over 100ha with 5km buffer

There are 4 sites identified within the District that are 100 ha or more and comprise Hopwas Wood, Gentleshaw Common, Chasewater and parts of Cannock Chase. When mapped alongside a 5 km (5,000m) buffer there are distinct areas with no access. These include most of the north and eastern area together with a large swathe to the south west of the District. There are 3 further sites which exceed 100 ha but are outside the District boundary: Sutton Park, Blithfield Reservoir and Kingsbury Water Park which are accessible from some areas of the District and provide access for populations residing in the north and south of the District. There is however still a gap in provision in the east of the District.

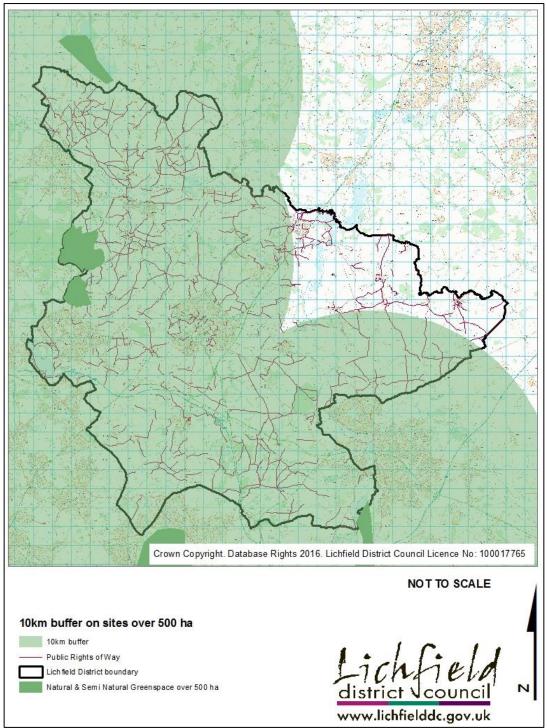
Map 5.5 Natural and Semi Natural Green Space over 500ha with 10km buffer

There are four sites of 500ha or more that impact on the District, Cannock Chase straddling the western boundary of Lichfield District with the other three located outside the District boundary. The four sites being Sutton Park, Blithfield Reservoir and Kingsbury Water Park and Cannock Chase.

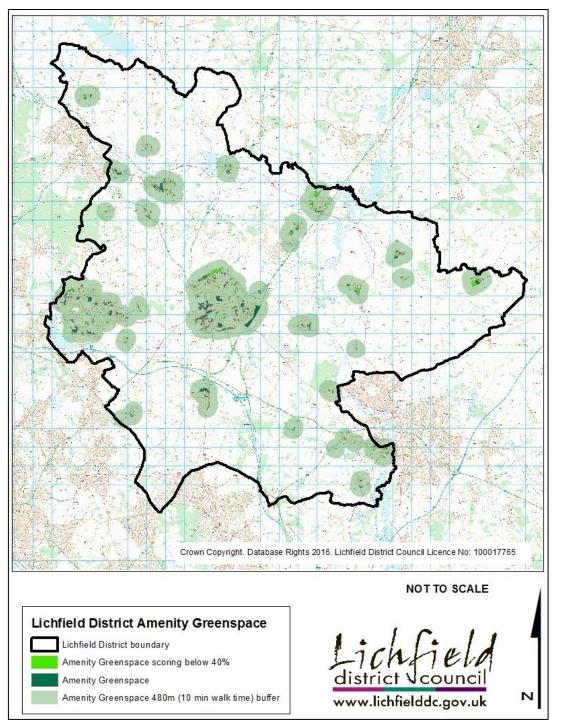
Map 6.1 Lichfield District Amenity Greenspace with 480m/10 minute walk time buffer.

Map 6.1 illustrates the distribution of amenity greenspace across the District as well as identifying those which scored below 40%. This demonstrates that the quality of greenspace varies across the District with concentrations of poorer quality spaces found within Lichfield, Burntwood, Fazeley, Alrewas, Armitage with Handsacre and Fradley.

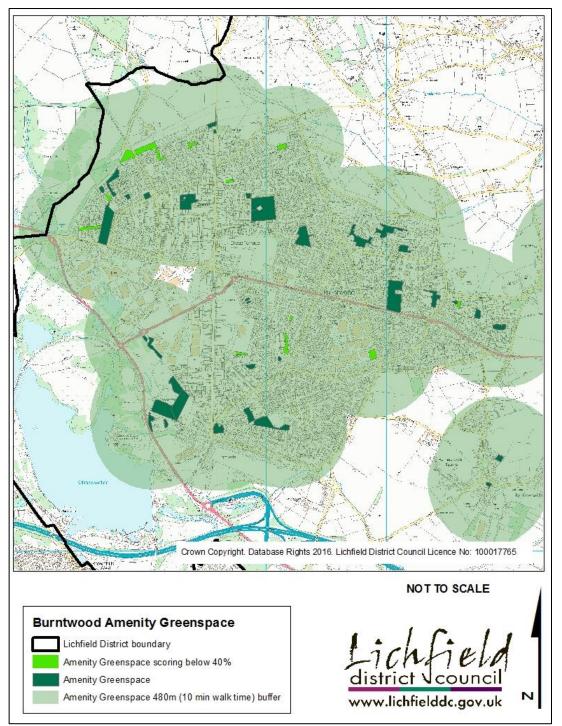
Map 6.2 Burntwood Amenity Greenspace with 480m/10 minute walk time buffer.

Accessibility: In terms of accessibility to amenity greenspace the majority of Burntwood residents have access to some form of amenity greenspace within 480m/10 minute walk time, as shown on Map 6.2. However this map also demonstrates that fewer and smaller areas of amenity greenspace are located within the south of the settlement especially to the south of the Cannock Road (A5190).

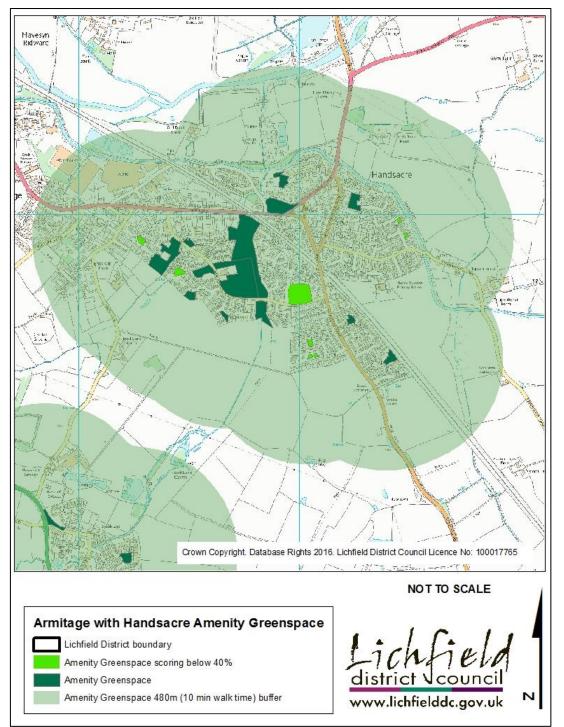
Map 6.5 Armitage with Handsacre Amenity Greenspace with 480m/10 minute walk time buffer.

Accessibility: Armitage with Handsacre has almost a complete coverage for the 480m/10 minute walk time. The exception to this is to the west of the settlement around Chapel Road, Church Lane and Upper Lodge Road. Although outside the settlement boundary, a Residential Mobile Home Park exists and this has no coverage either by the Hawksyard development to the west or the main settlement of Armitage to the east.

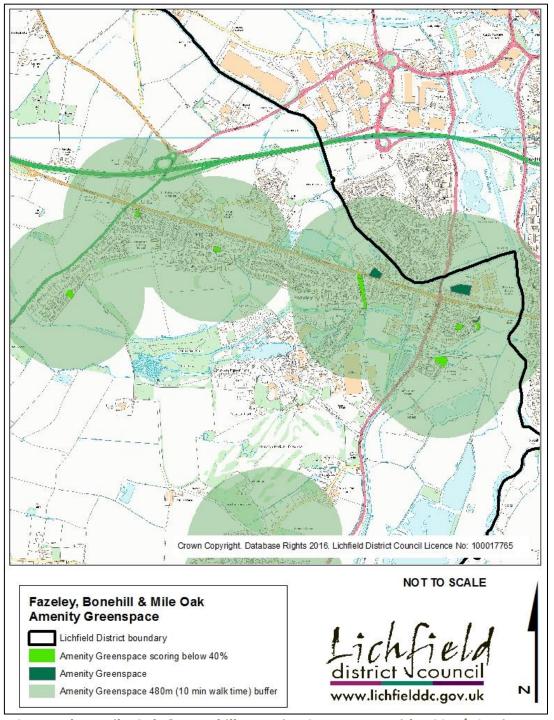
Map 6.7 Fazeley, Mile Oak & Bonehill Amenity Greenspace with 480m/10 minute walk time buffer.

Accessibility: Largely due to the linear form of Fazeley, Bonehill and Mile Oak, the settlement has almost complete coverage when the 480m/10 minute walk time buffer is applied. In terms of accessibility to the larger spaces, namely Laurel House, Mayfair Drive and Victory Terrace these are located in the east of the settlement and as such are not easily accessible by residents of Mile Oak. Additionally the greenspace to the rear of Victory Terrace is not

easily accessible as it is separated from the majority of the settlement by busy road, and it is also hidden from view leading to concerns about natural surveillance and safety.

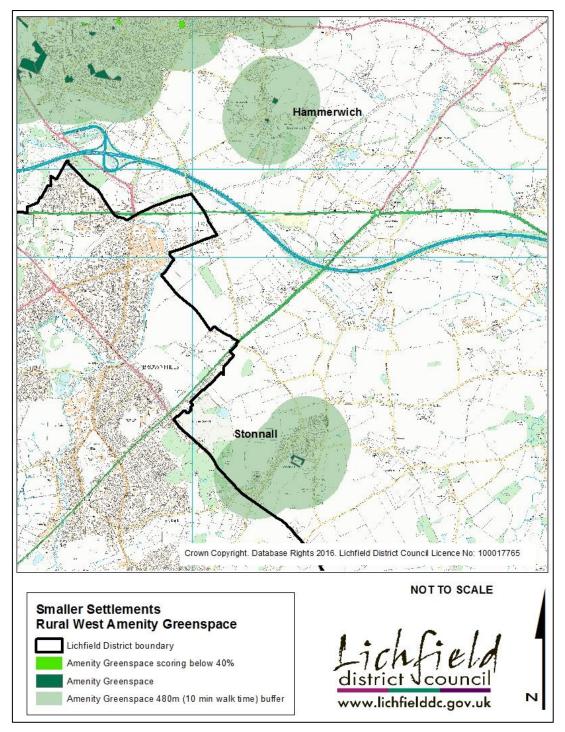
Map 6.13 Rural West Amenity Greenspace with 480m/10 minute walk time buffer

Quantity: Within this area there are only 2 settlements, Hammerwich and Stonnall with 2 and 3 areas of amenity greenspace respectively. The largest site being around the Playing Fields at Stonnall and providing 0.6 ha.

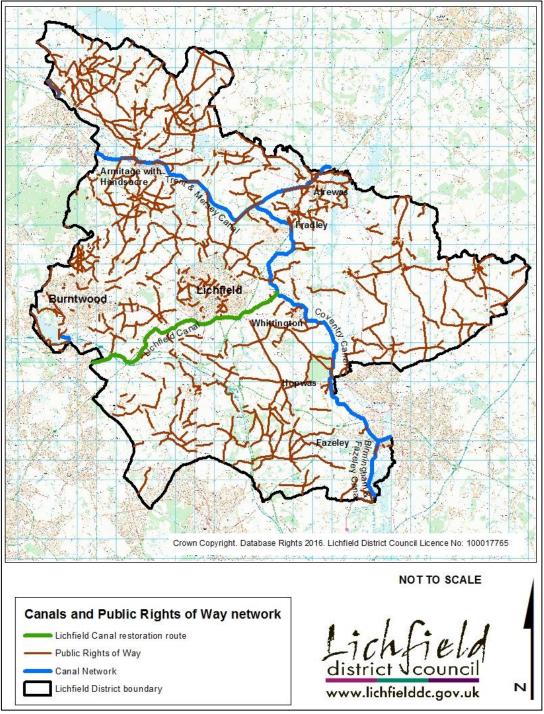
Map 7.1 Canal and Public Rights of Way Network within Lichfield District

Lichfield District is crossed by three canals, namely the Coventry Canal, Birmingham and Fazeley Canal and the Trent and Mersey Canal. Whilst initially constructed for the transportation of goods, the canals in more recent years have become a destination for leisure boaters, walkers and cyclists as well as operating as efficient green corridors.

Several settlements within the District are situated along these canals and include Armitage with Handsacre, Fradley, Alrewas, Whittington, Hopwas and Fazeley. In addition there is also extensive ongoing work to restore and reopen the Lichfield Canal by the Lichfield and Hatherton Canals Trust.

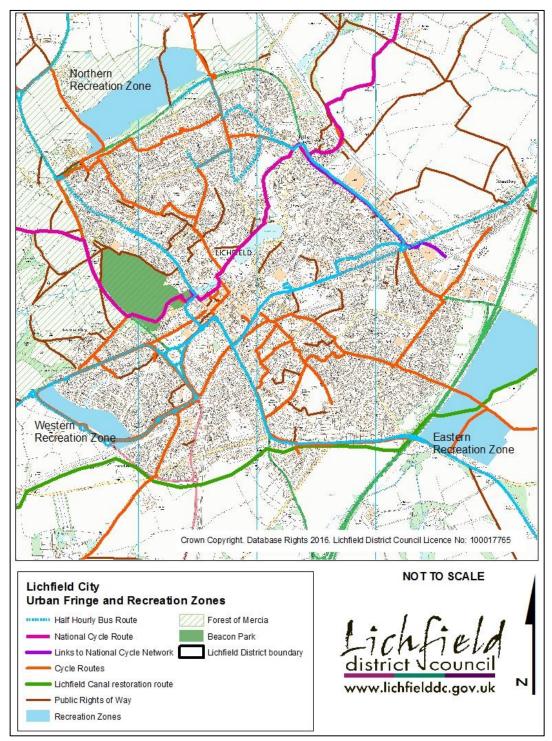
Map 8.1 Lichfield City Urban Fringe

On the periphery of Lichfield there are a number of urban fringe spaces including three areas designated within the 1998 Lichfield Local Plan as recreation zones. Two of these areas have been developed for recreation and sport, namely the Northern and Eastern Recreation Grounds. The Western Recreation Zones currently remains as agricultural land, this has the benefit of extant planning permission for residential development. The future of this recreation zone will be considered through the Local Plan Allocation process.

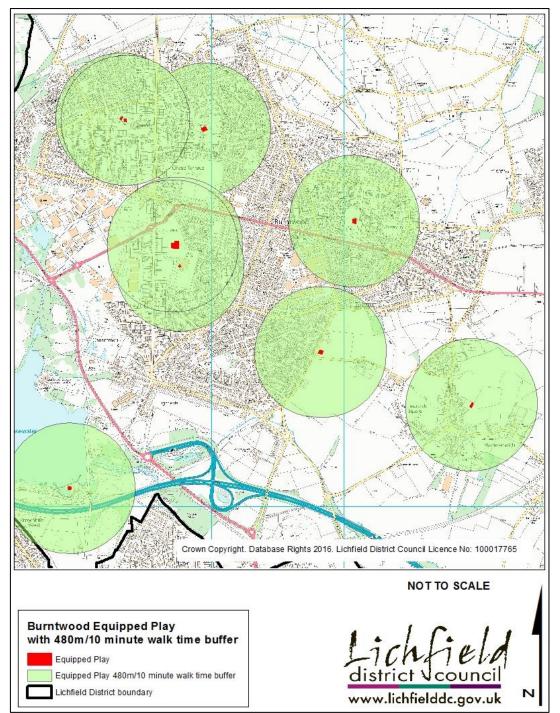
Map 9.4 Burntwood Equipped Play with 480m/10 minute walk time buffer

There are too few equipped play space locations within Burntwood, resulting in a substantial percentage of the settlement lying outside 480m/10 minute walk time to an equipped play space. Opportunities to create new play spaces should be sought where development opportunities arise particularly in area where there is no access within 480m/10 minute walk time.
